BUILDING CONDITIONS ASSESSMENT  
*for*  
Fitch Middle School  
Town of Groton, Connecticut

*Architect:*

TLB Architecture, LLC  
92 West Main Street, Chester, Connecticut 06412

February 27, 2015

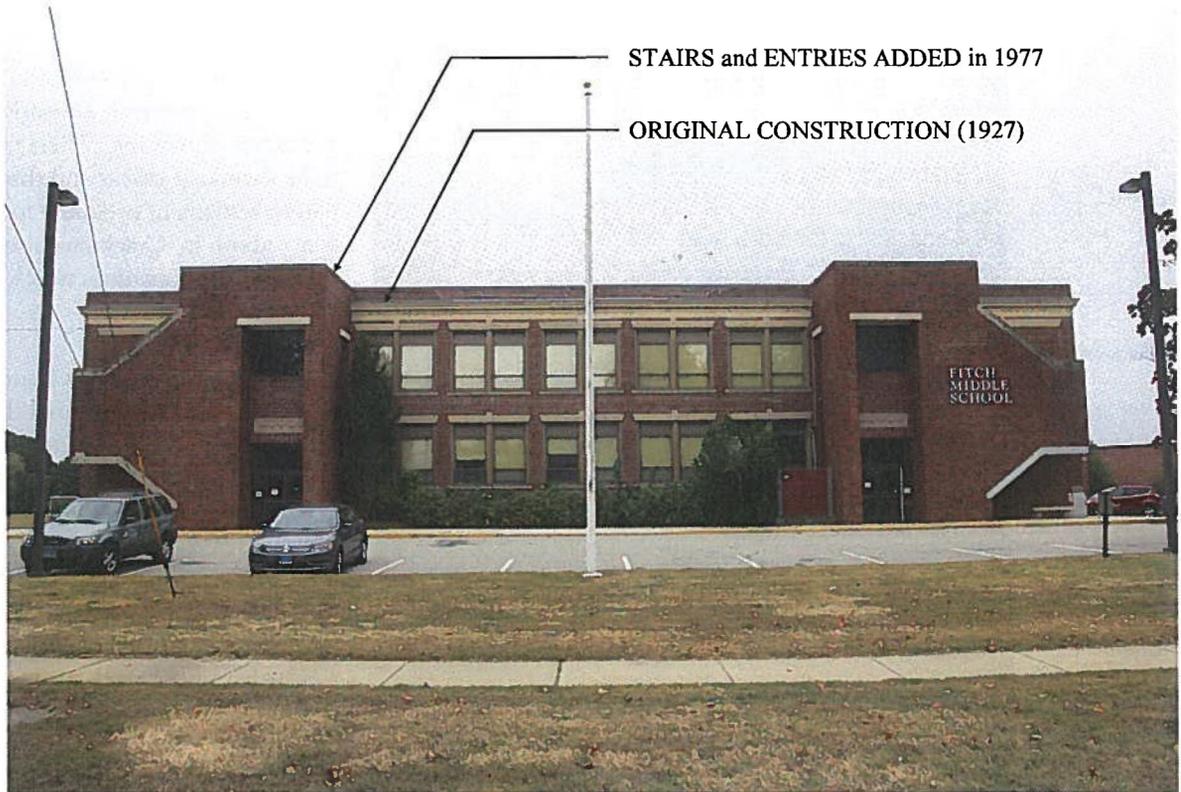
North Façade

Basic building assemblies are brick masonry with limestone cornices, lintels and sills. The masonry walls sit on a cast-in-place concrete foundation. Windows and doors have been replaced with aluminum units.

The majority of the original construction and the 1977 additions are in good condition, with only routine maintenance required. Some of this maintenance has been deferred, and as such will require more careful attention in the short-term to ensure continued service life of the building systems and assemblies.

The roofing is a mechanically adhered EPDM, in very poor condition.

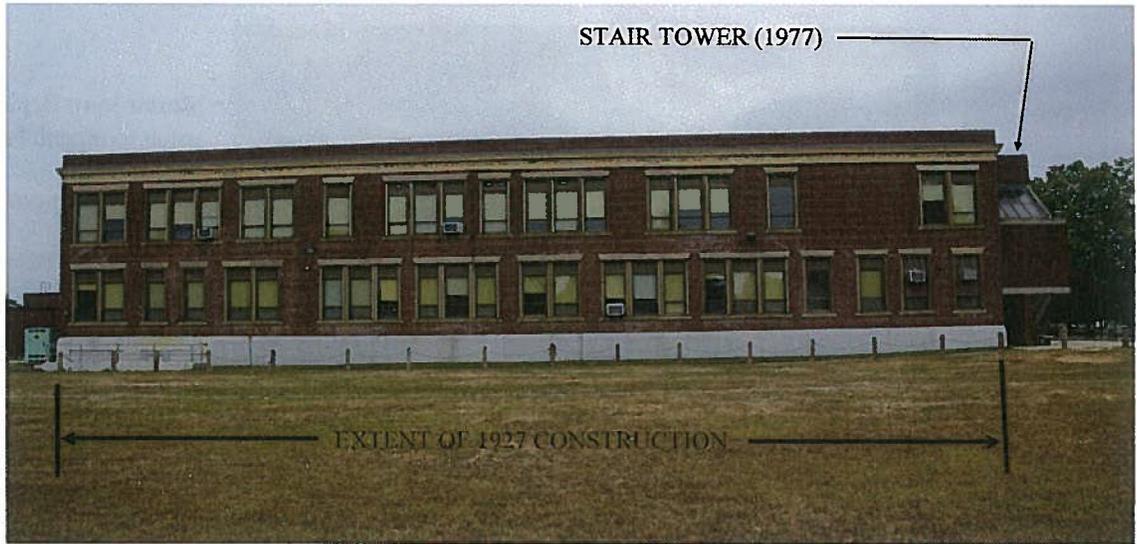
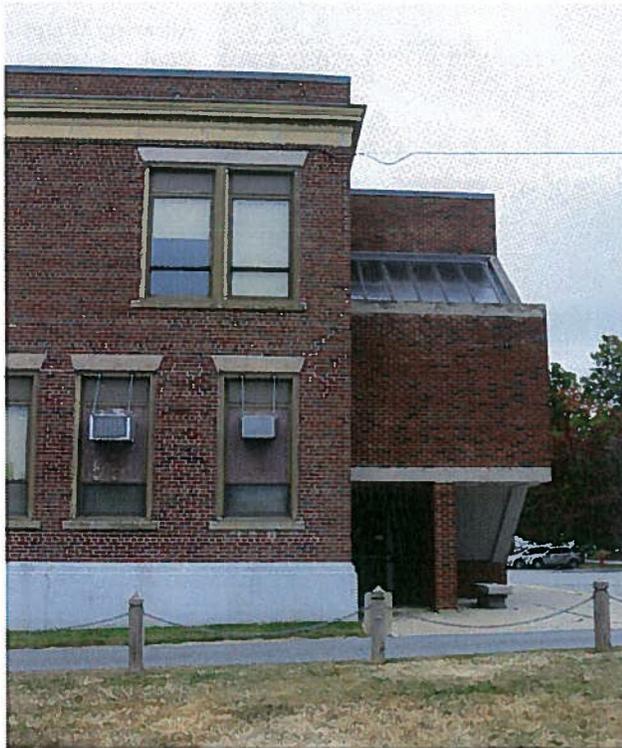
East Façade

The original brick surfaces are in need of miscellaneous repairs and a full re-pointing. While the brick is generally sound, the joints are deteriorated. There are also signs of water infiltration into the walls, as exhibited by the efflorescence and staining on the exterior surfaces.

Joints at limestone lintels and sills have deteriorated significantly and many have been repaired with sealant as opposed to mortar. Some mortar joints have been repaired with an unknown mortar mix that is not an acceptable match. Many joints are “lipsticked” over the face of brick, which accelerates deterioration.

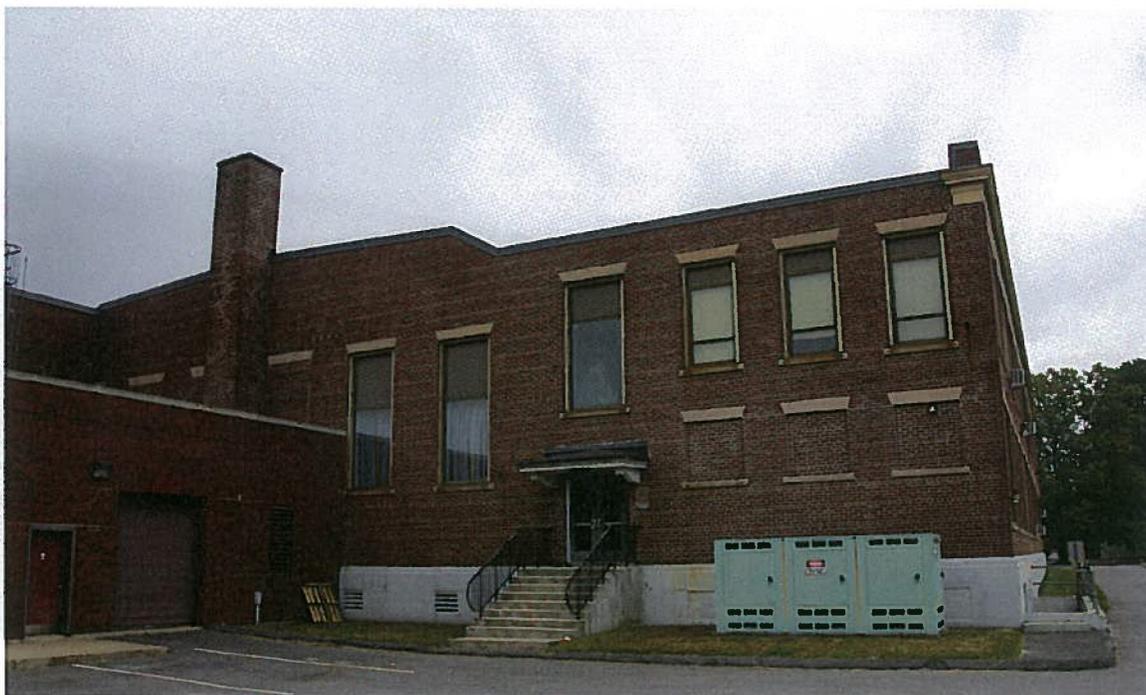
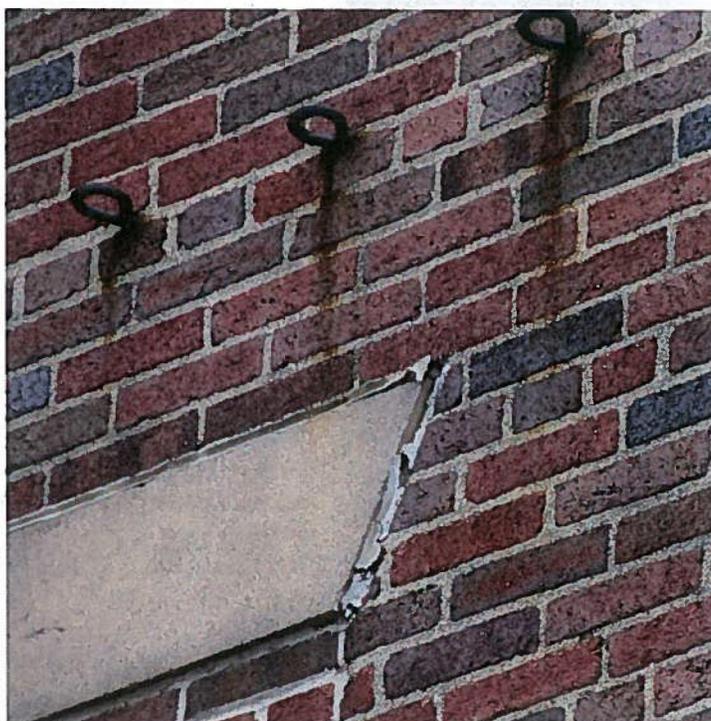
South Facade

The south façade exhibits many of the same deferred maintenance issues as the north and east façade. Sealants used in lieu of mortar joints are further deteriorated due to southern exposure, leaving large open joints where water can enter the walls.

Embedded steel hanging devices are staining the brick and will accelerate deterioration of the joints. These embeds should be removed and the wall patched.

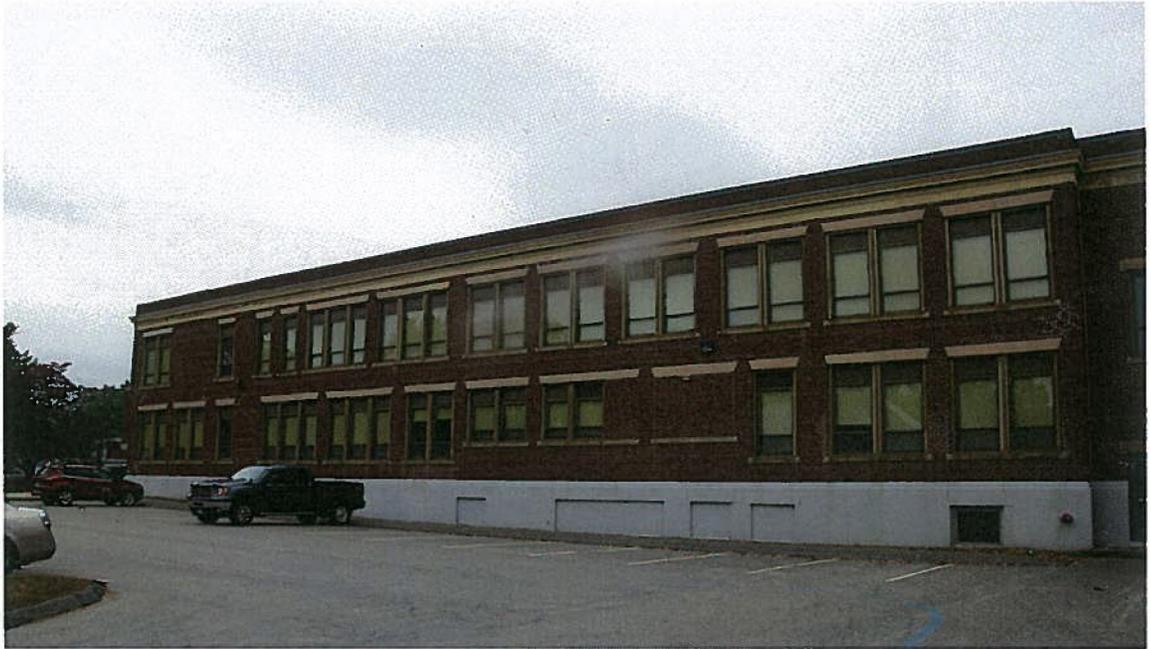
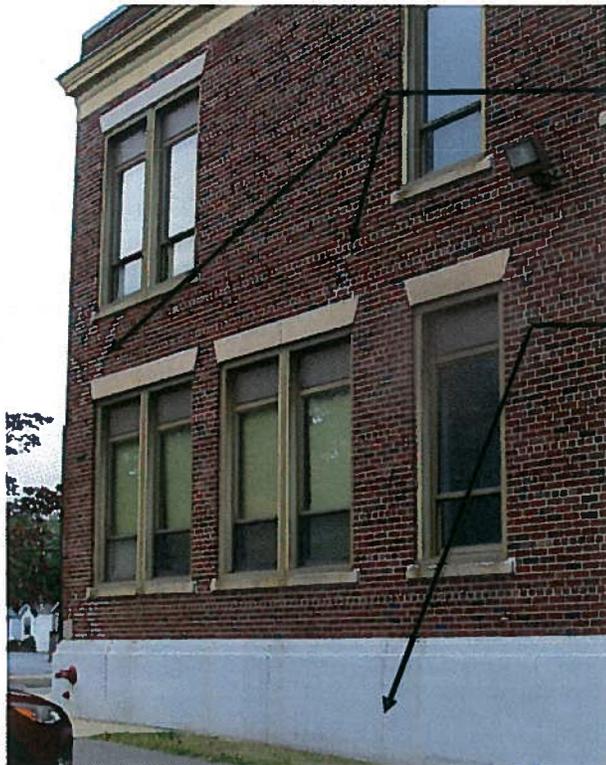
West Facade

Brick Repairs Throughout

Cracks in Foundation Walls, Typical

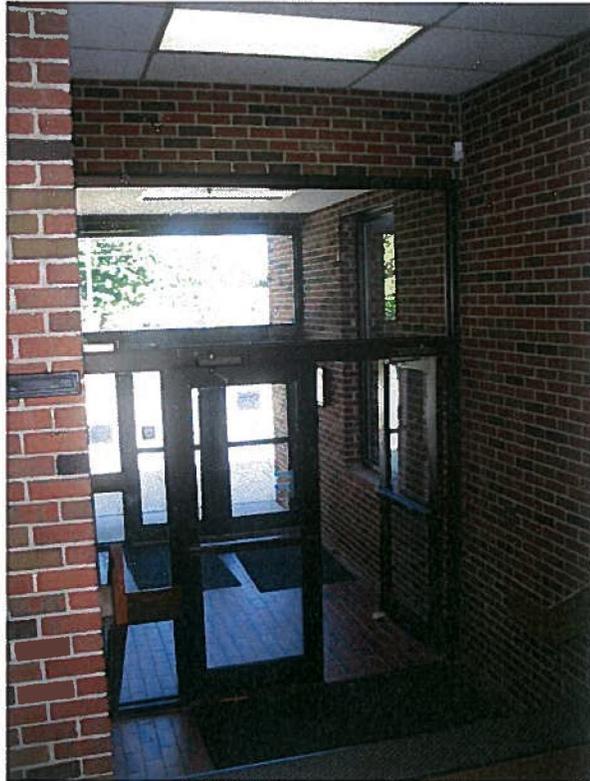
Interior materials and finishes at the entries at the north side are durable and in good condition. These entries provide no handicapped accessibility. Hand rails on the stairs are not compliant and would likely need replacement when the building is renovated.

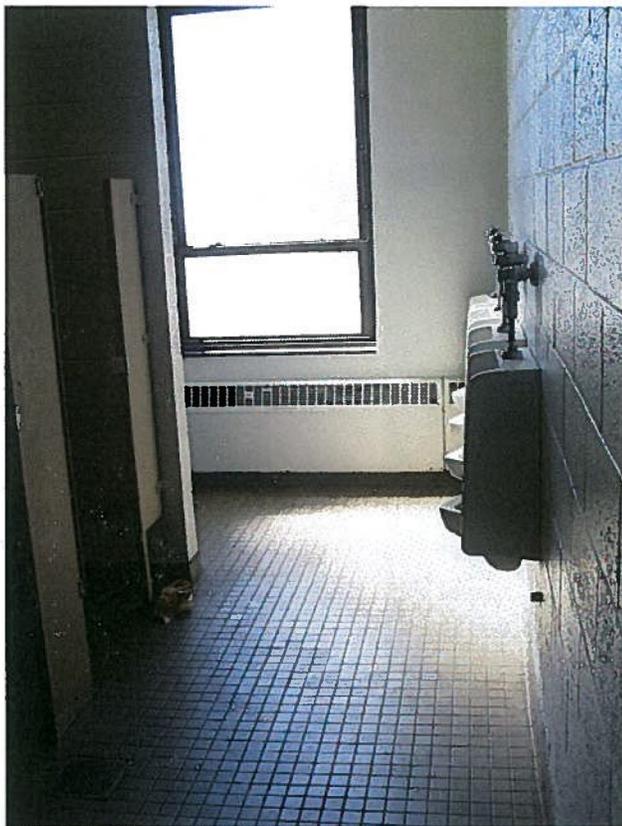
Toilet rooms are constructed with painted CMU partitions. Exterior walls are painted GWB, as are the ceilings. Floors and base are ceramic tile. While finishes are in good condition, the toilet rooms are not handi-capped accessible and will require some renovation to achieve compliance.

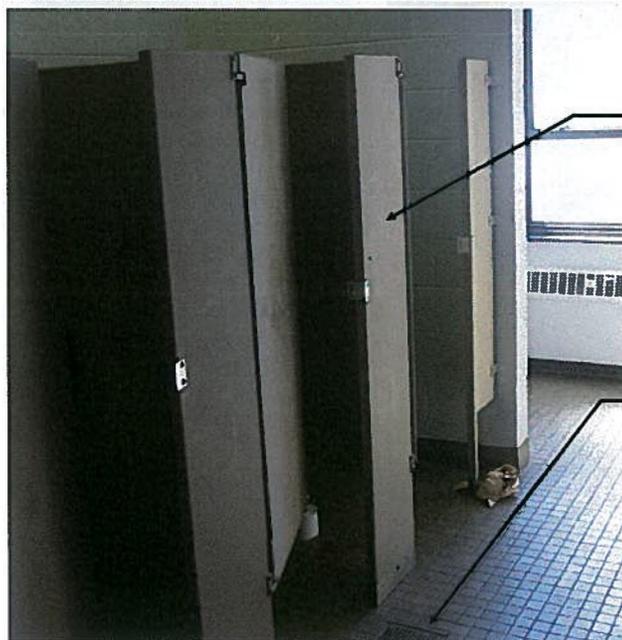
Toilet partitions are solid plastic and in fairly good condition.

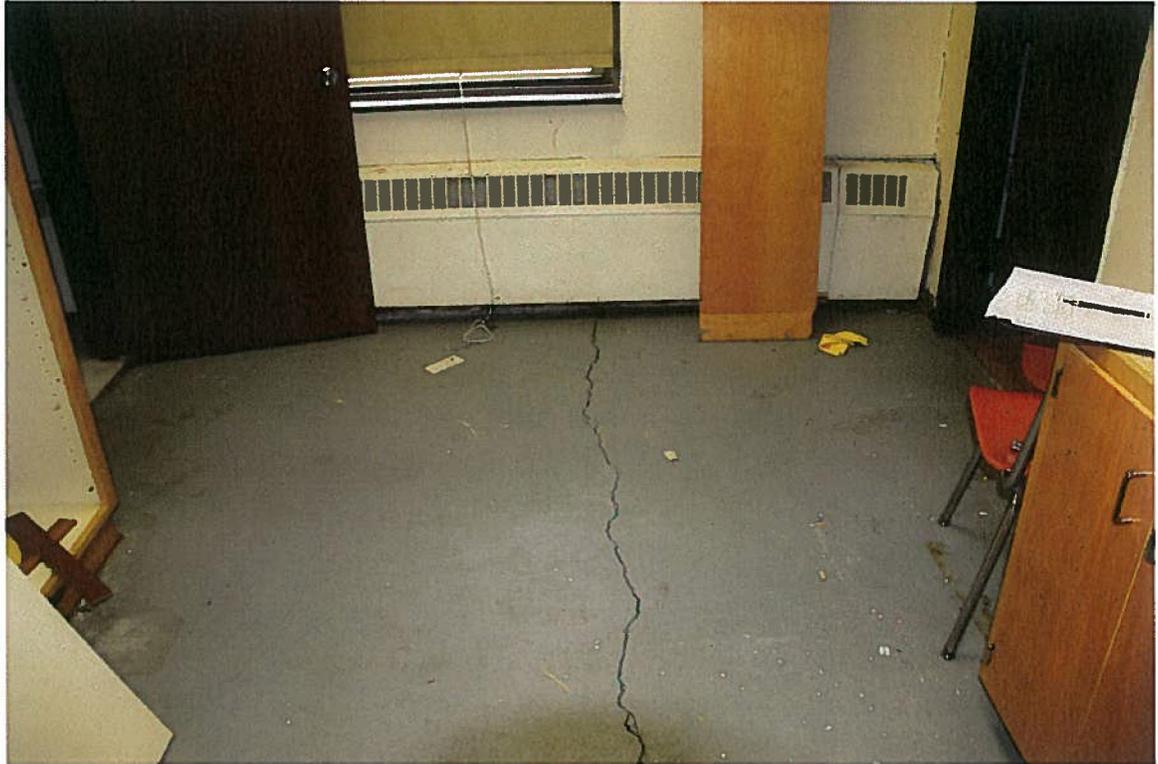
There is a significant crack in the concrete floor slab on the second level, within Room 203B. This crack runs the full length of the room and branches in multiple directions at the ends.

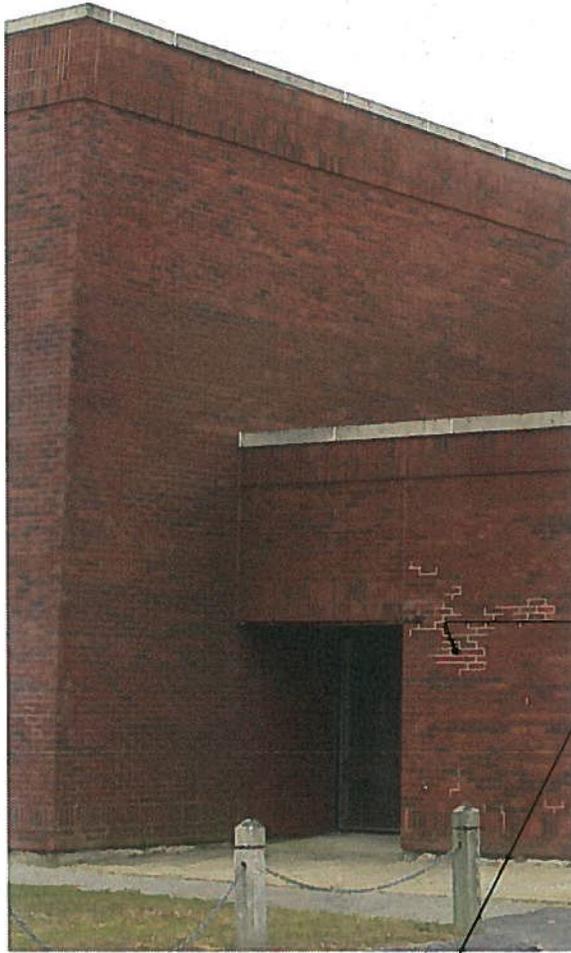
The tops of masonry walls are capped with a cast-stone coping. The copings are generally in good condition, but the joints have signs of deterioration. Some copings are mis-aligned. There are signs of water infiltration into the masonry walls, and the source appears to be both the coping joints and failed sealants at the control joints. The wetting of the wall appears to be the worst at the north wall of the gymnasium.

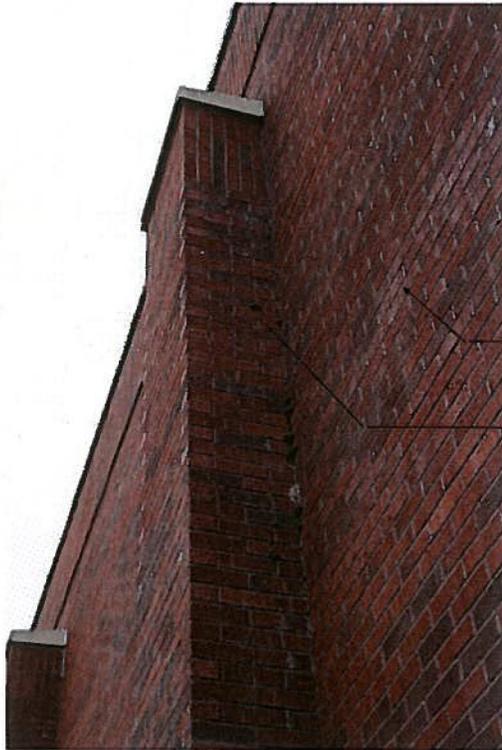
Water appears to be infiltrating the pilasters, likely through the cap flashing and control joints, which align with the edge of the pilaster.

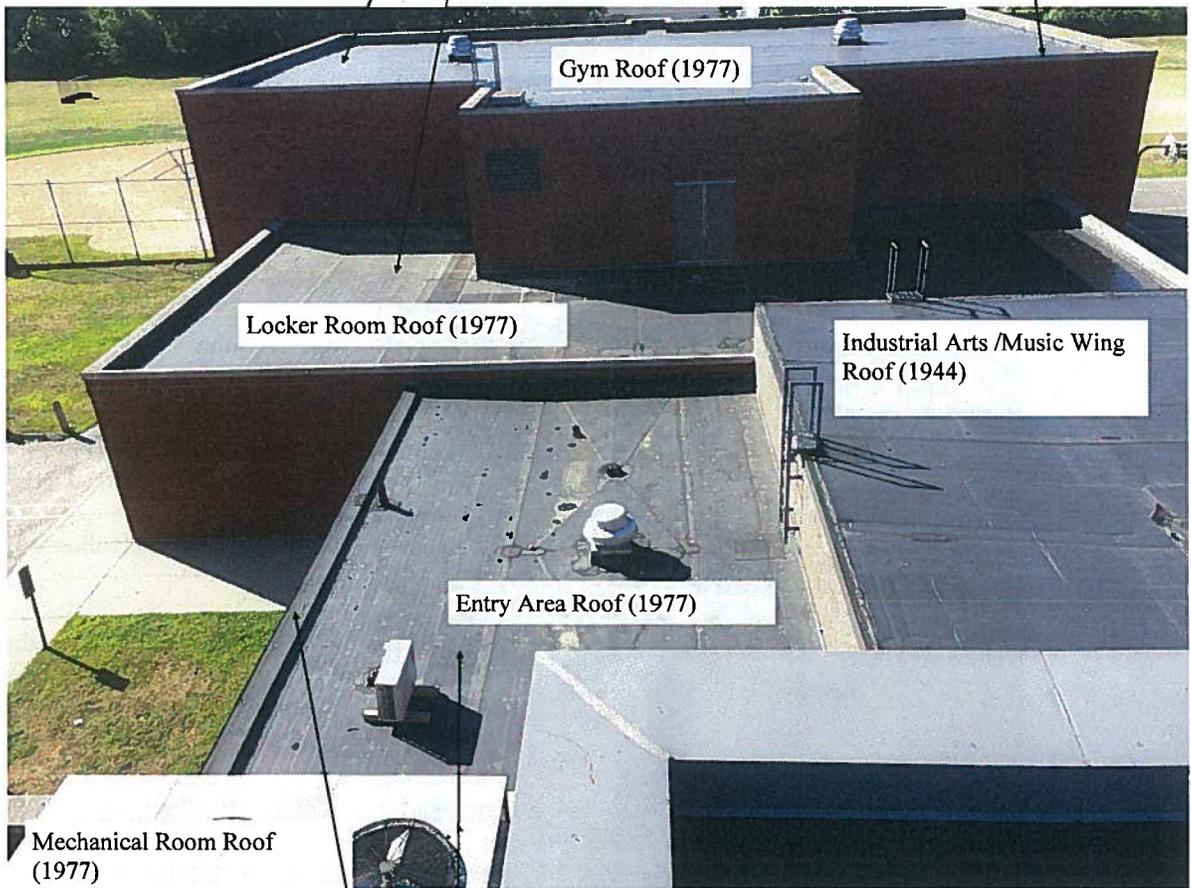
Roof Over Entry Area: Mechanically fastened and ribbon-adhered EPDM is in generally good condition and requires routine seam and flashing maintenance. Particular attention is required at flashing that transitions into wall of 1944 wing.

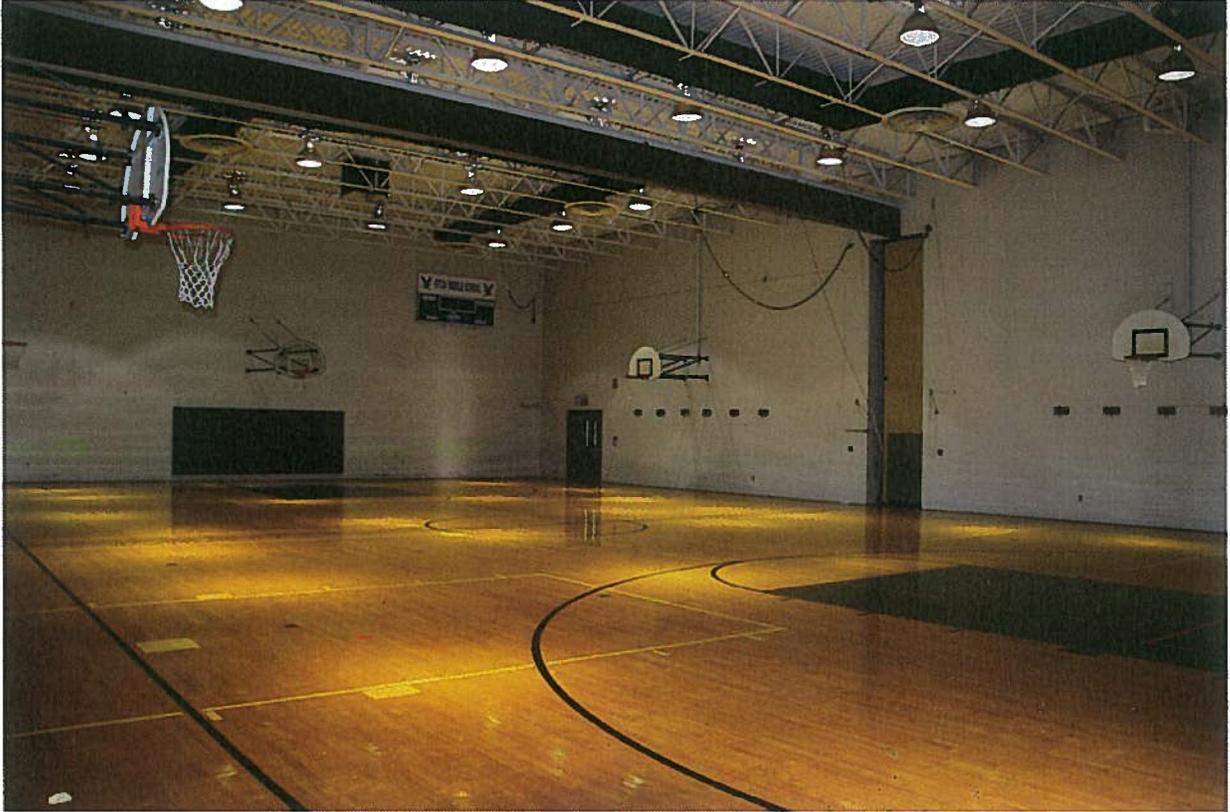
The gymnasium is the largest volume within the B-Wing and consists of an 84-foot basketball court with a hardwood floor. The floor is in generally good condition, though there is some damage from water or moisture at the east end.

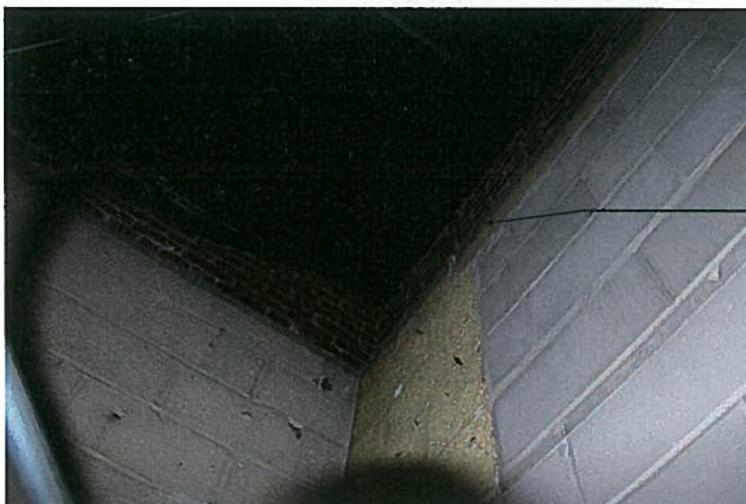
Southwest corner of Music Room that forms the completion of the Fire Wall. The wall assembly needs to be evaluated as the brick portion may not provide the required fire-resistance rating.

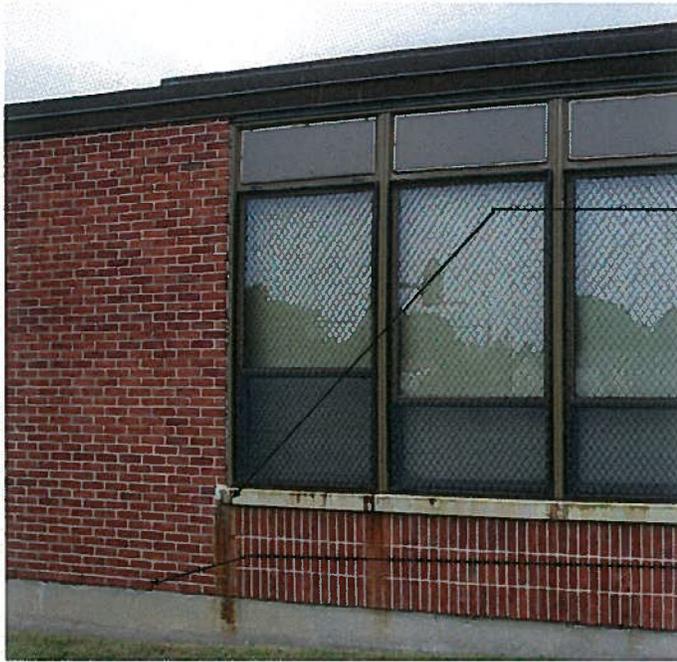
Windows are heavily weathered and the metal screens are rusting, resulting in staining and deterioration of cast-stone sills and brick.

Weeping at the base of wall is inconsistent and the wall cavities are apparently not vented.

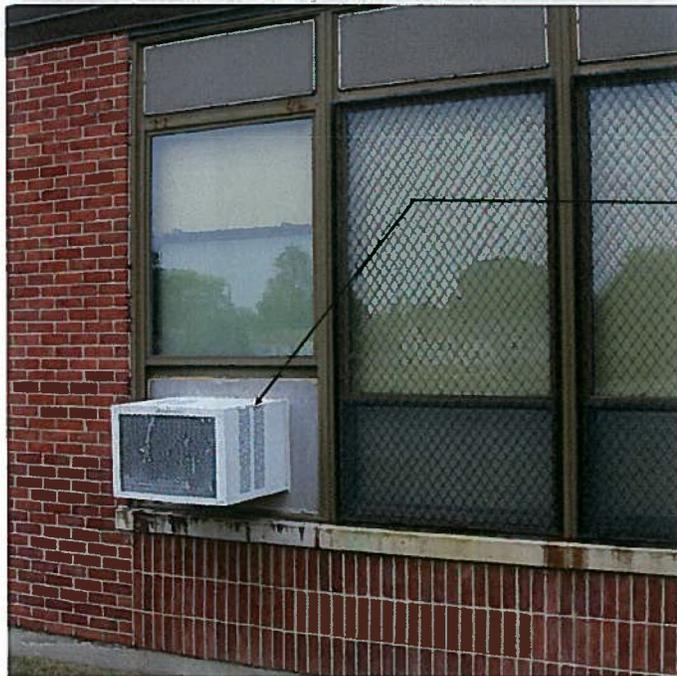
Window air-conditioning units compromise the integrity of the window system. The removal of the security screen renders all screens ineffective by creating an easy point of access.

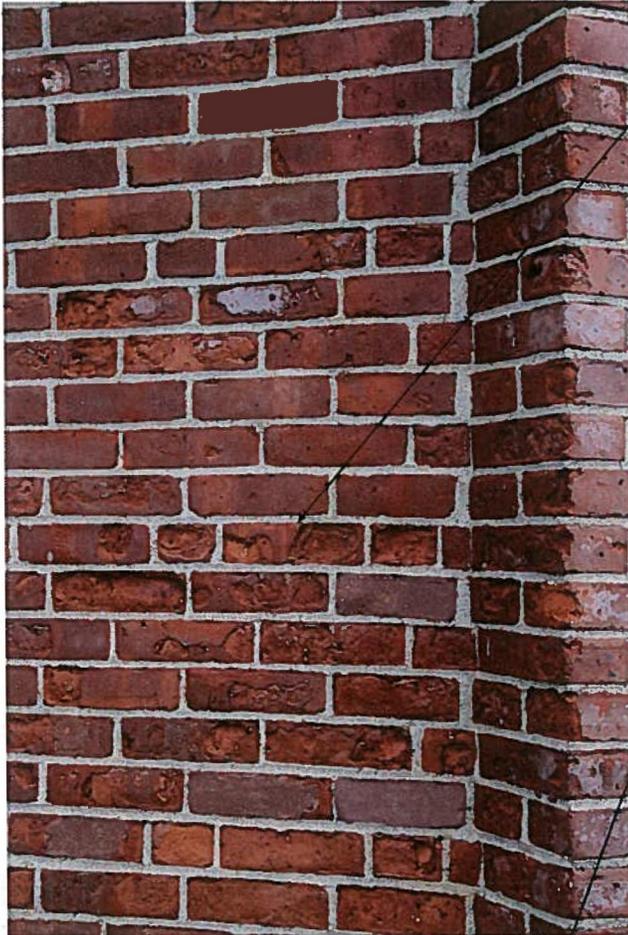
Heavily weathered brick, typical throughout all of D-Wing, most prominently on the east and south facades.

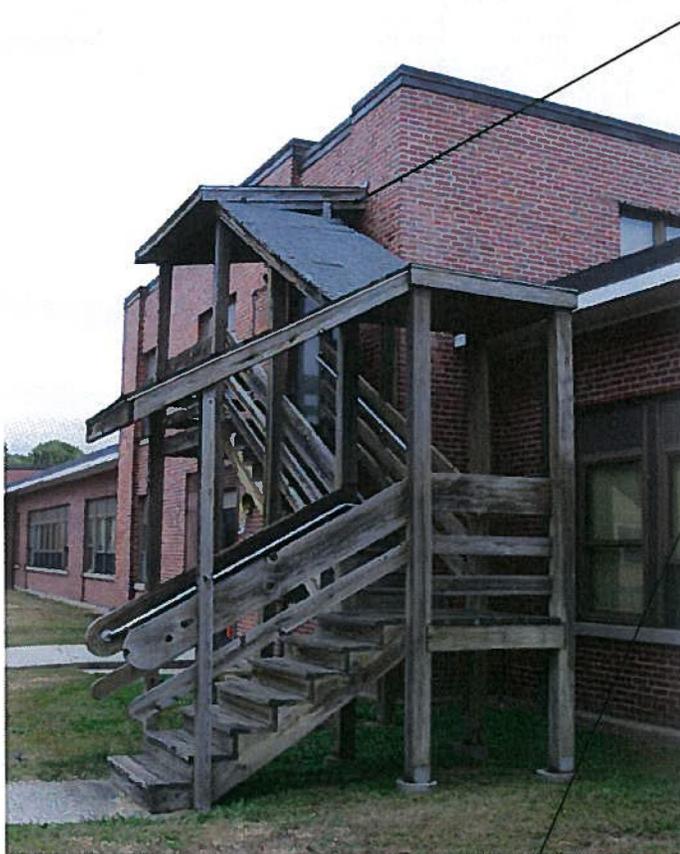
A wood exterior fire escape was constructed to provide a second means of egress from the second level of D-Wing. This stair is in generally poor condition and is not compatible with the architecture of the building. If continued use of the second floor is planned with a use that requires two means of egress, then this stair should be replaced with a new fire stair.

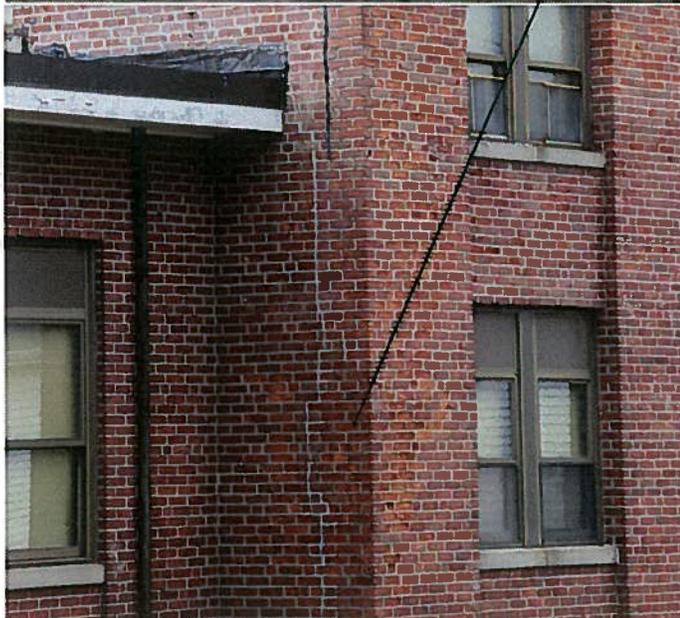
Failed joints at sills and at window perimeter allows water penetration into building and wall assemblies.

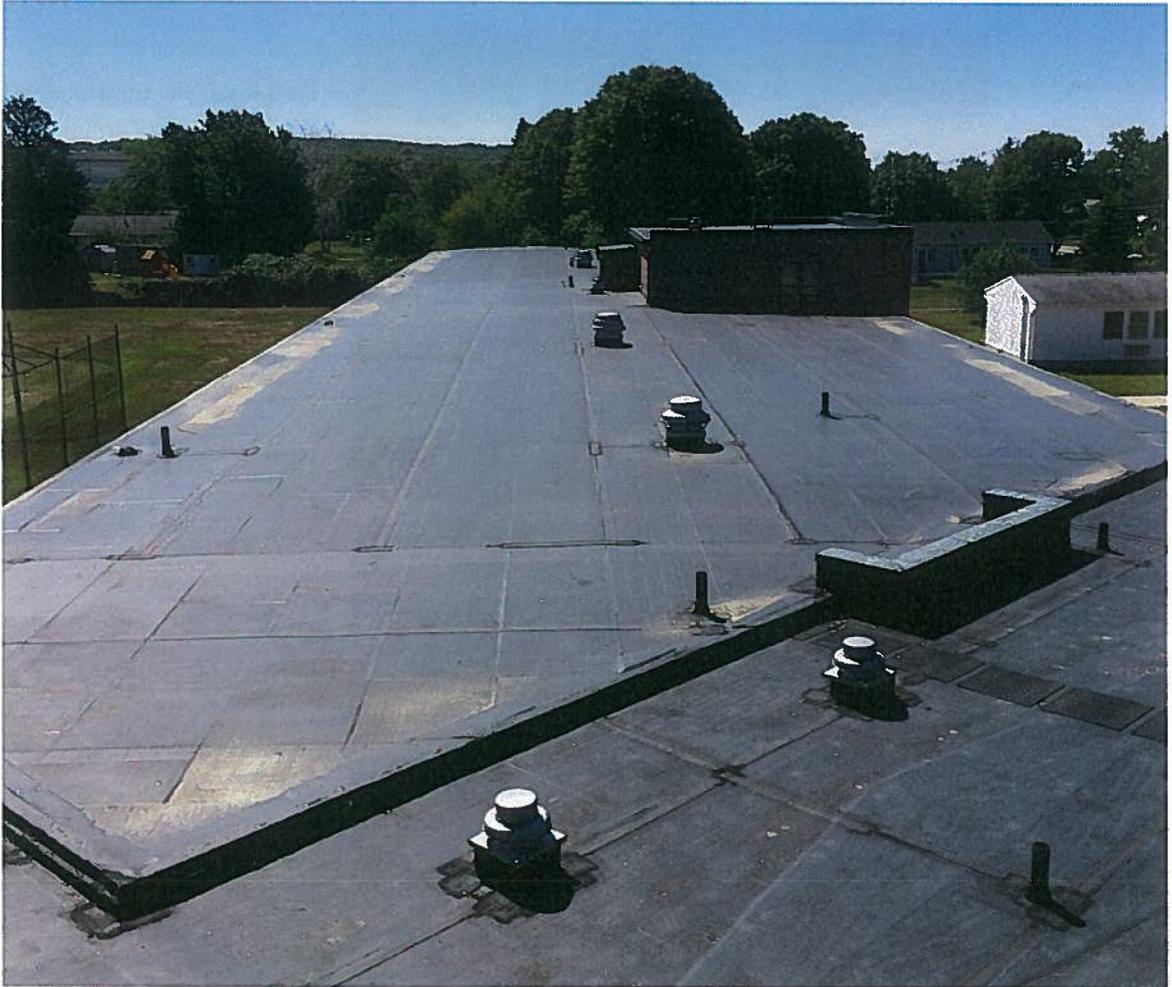
The D-Wing roof is a 2" concrete plank deck with rigid insulation above it. Roofing is an adhered EPDM membrane. The roofing was installed in 2001 and is in need of maintenance to maintain watertightness. Many of the substrate boards are misaligned and loose. In addition to causing eventual damage to the roof, there are thermal bridges in the insulated layer which significantly reduces the efficiency of the insulation. There are no walkway pads installed to protect the surface. Roof drainage is accomplished by means of roof drains spaced evenly at the overhang along the perimeter of the roof. A tapered edge pitches to the drains, which discharge through rainwater leaders installed through the soffits.

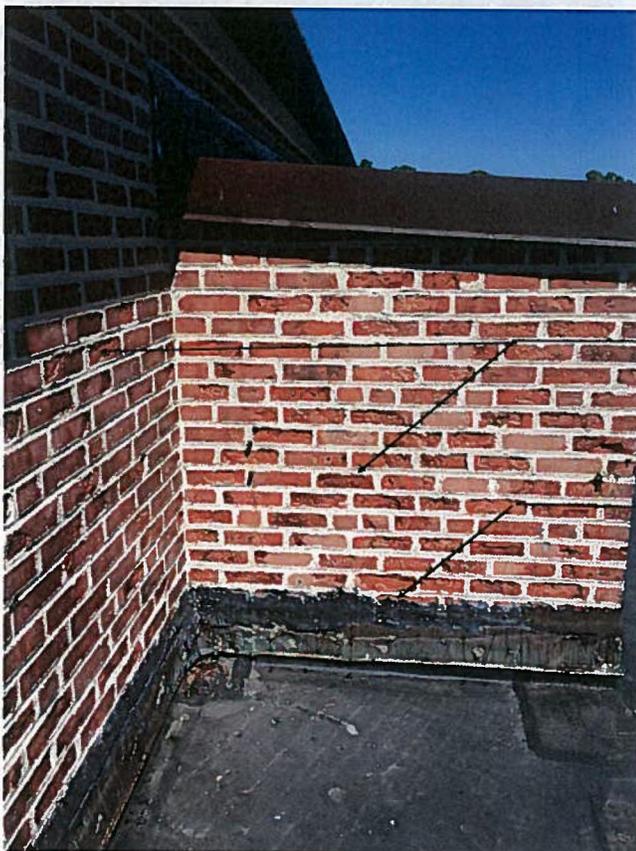
Brick veneer is exhibiting the same severe weathering noted at the lower level.

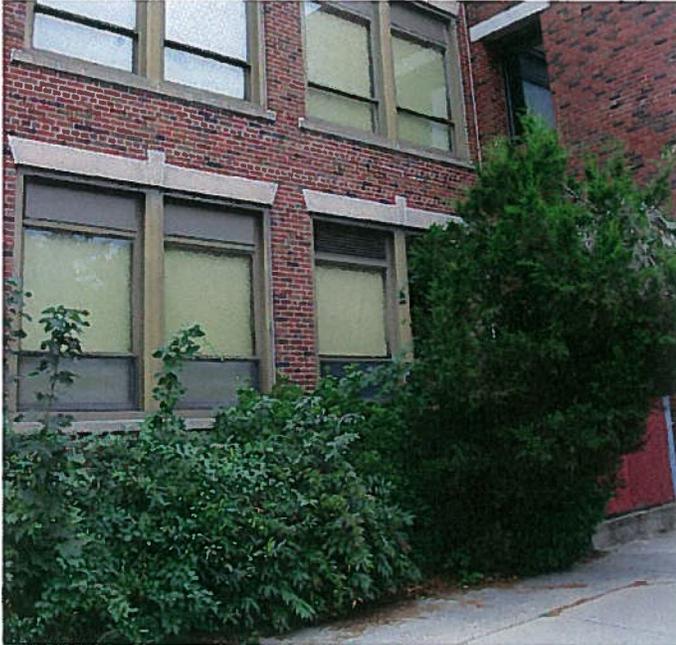
Plantings against the building should be cut back to allow damp areas to dry out and to prevent screening from the street.

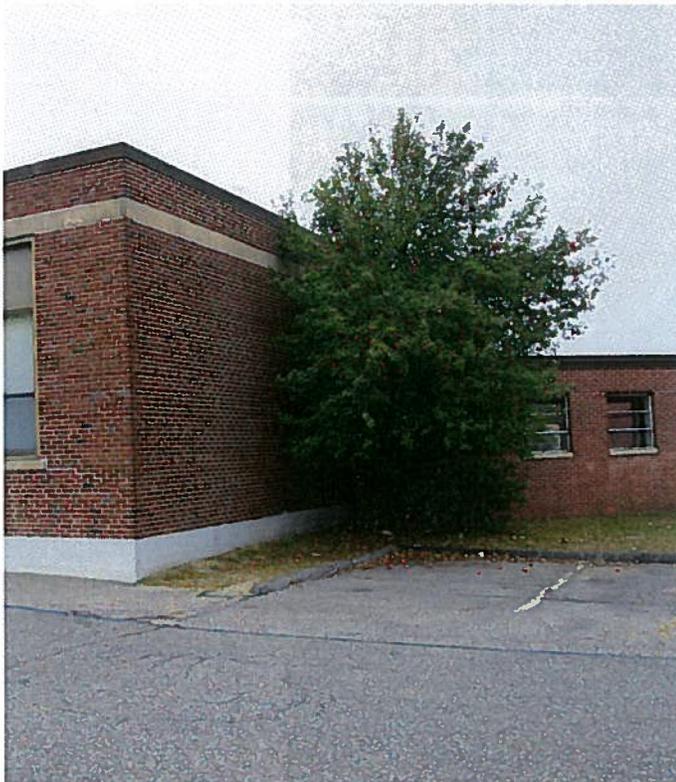
The apple tree planted near the connector should be removed. This type of tree is not appropriate for a foundation planting, as the roots can cause damage to the foundation.

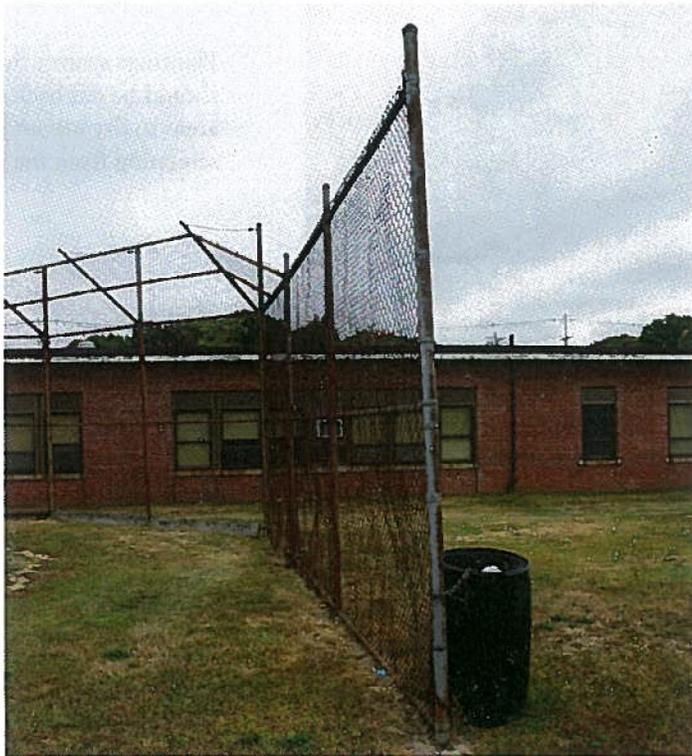
Backstops and fencing are rusting and the bases of the chain-link is in poor condition. All fencing should be replaced to provide proper protection to players and spectators.

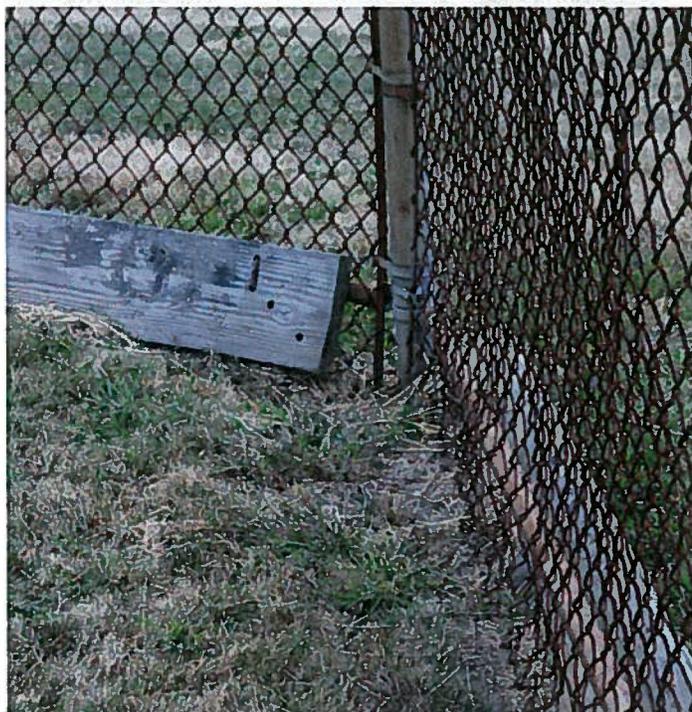
Rusted fencing, sharp edges, loose boards and uneven turf present hazards to players.

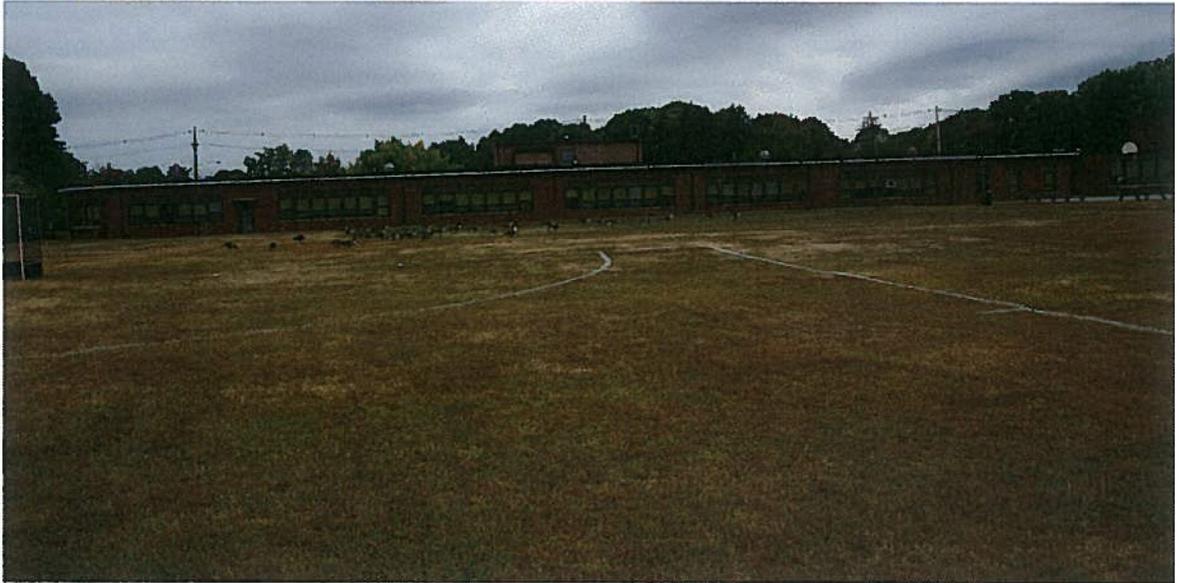
Ball fields are playable but depending on the desired level of quality, can benefit from a turf management plan and irrigation. Lips at the transition from infields to outfields should be leveled to avoid trips and bad hops.
