BUILDING CONDITIONS ASSESSMENT  
*for*  
Fitch Middle School  
Town of Groton, Connecticut

*Architect:*

TLB Architecture, LLC  
92 West Main Street, Chester, Connecticut 06412

February 27, 2015

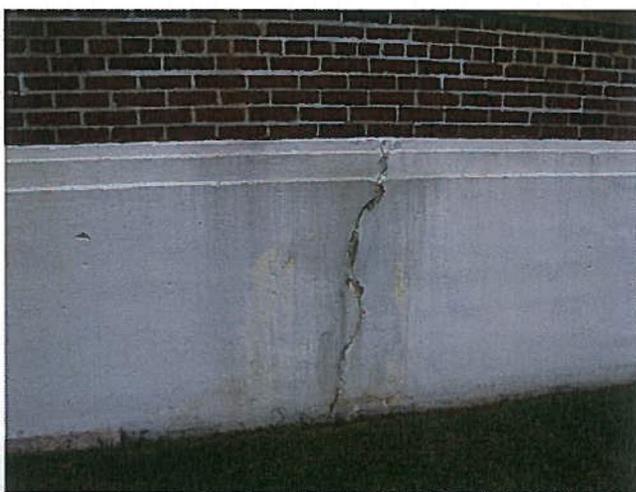
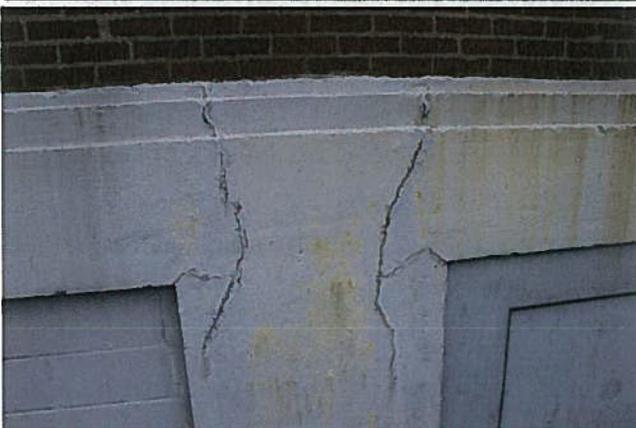
The foundation wall exhibits cracking at fairly regular intervals at nearly the entire perimeter of A-Wing. These cracks appear to be shrinkage cracks and there is no apparent settlement or failure to support masonry above it. Cracks are also visible off the corners of openings which were cast into the concrete.

The cause of these cracks is unknown and they may have first appeared shortly after the building was constructed. Their random path is indicative of shrinkage cracks, which is often the result of rapid drying of the concrete while it is curing, lack of steel reinforcing or lack of control and/or expansion joints. In this case, it is likely a result of multiple causes. It appears a variety of repairs have been attempted over the years with limited success.

1. The entire A-Wing Roof needs to be replaced. Anticipating reuse, it would be prudent to install a roof that complies with the Energy Code, as opposed to a replacement in kind.
2. Cracks in the foundation should be repaired using epoxy injection.
3. The crack in the second level floor slab should be repaired with epoxy injection.
4. Sealant should be replaced around all windows, doors and openings.
5. Concrete at the top of the area-way walls on the east side should be repaired.
6. Remove through window air-conditioners and replace windows.
7. Remove soft joints at limestone lintels and sills and install masonry mortar.
8. Replace expansion joints with properly sized pre-manufactured joint system.
9. Remove rusting, abandoned steel embeds and patch masonry.
10. Patch exposed rebar at concrete stair slabs.

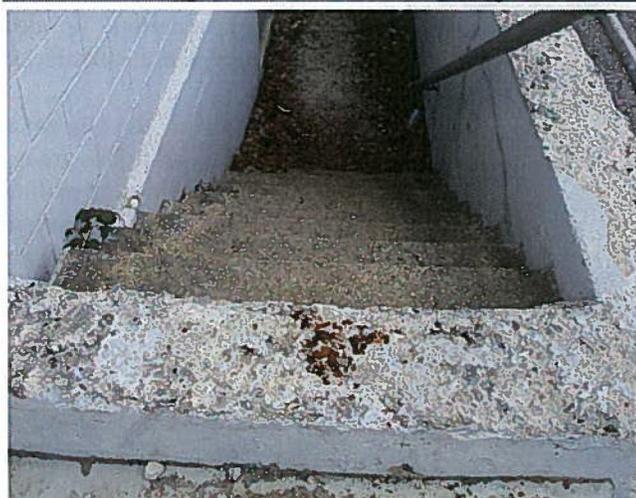
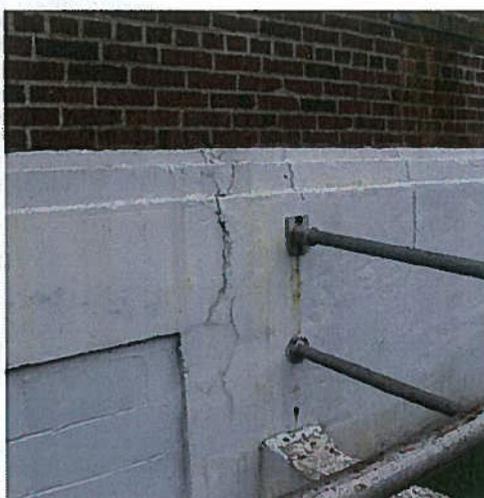
At the area-way at the southeast corner of the building, the top of the concrete wall is heavily decayed and puts both the integrity of the concrete and the stability of the railing in jeopardy.

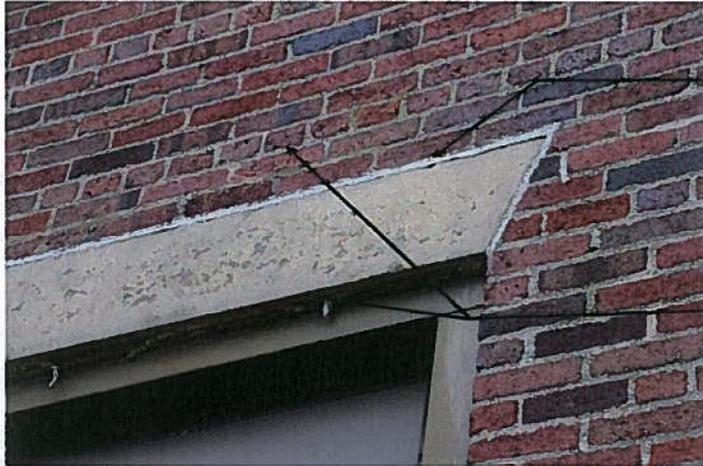
Mortar Joint Replaced with Sealant at Concrete Lintels

Flashing and Weeping has been Interrupted by use of Sealants. The Staining Above the Lintel is Indicative of Trapped Water/Moisture. Sealant Below Lintel is in Total Failure.

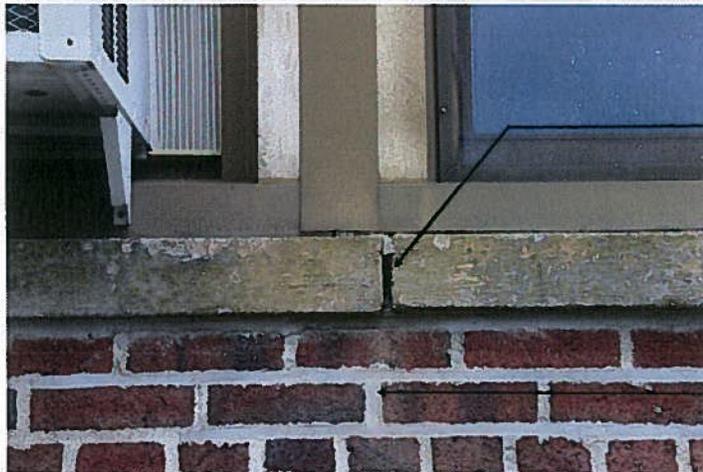
Sill Joints are Deteriorated and Allowing Water into Masonry Wall

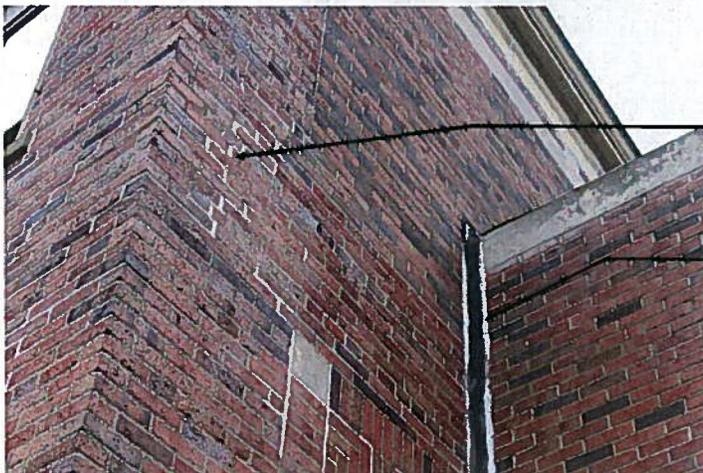
Improperly Tooled ("lipsticked") Joints Allow Deterioration of Brick to Occur at a More Rapid Rate

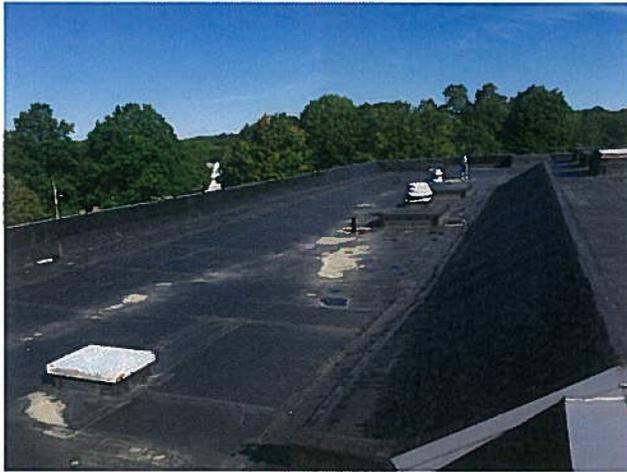
The A-Wing Roof appears to be a combination of mechanically and adhered EPDM membrane that is in generally very poor condition. In many locations it is in complete failure. Failed mechanical connections, abandoned penetrations, and damaged flashings and terminations are all contributing factors.

Invasive exploratory investigations were not performed, but it appears that the insulation layer below the membrane has failed in many areas.

The A-Wing roof is in need of complete replacement. Replacement should include the removal of abandoned penetrations.

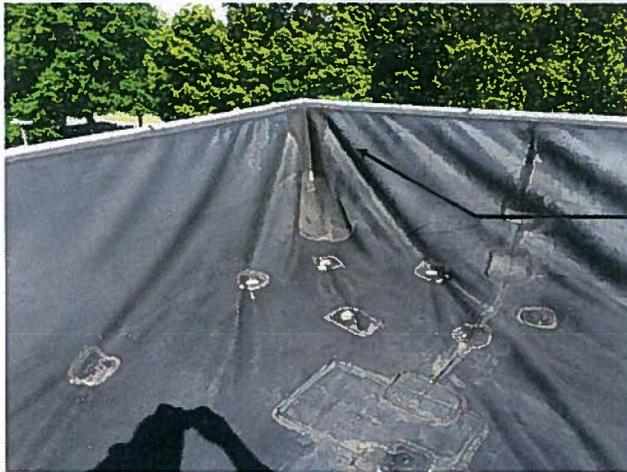
Roofing runs up to the top of the parapet and has completely pulled away from the substrate. Multiple patches have been made over time and sandbags are currently used to ballast the roof in some locations.

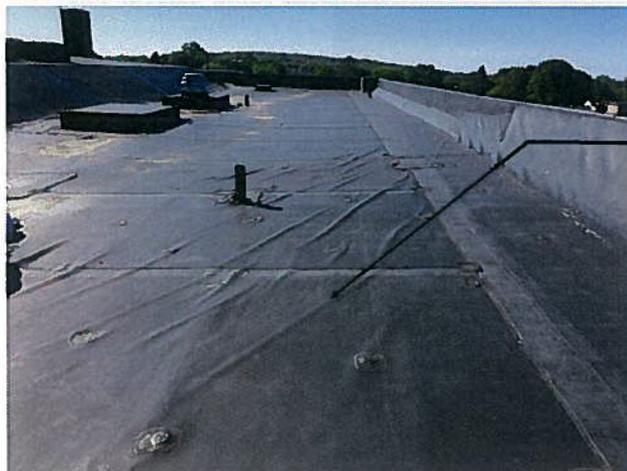
Lack of mechanical adhesion allows ripples, sags and bellows to occur, reducing wind resistance, trapping water and preventing proper draining of the roof. Roof drains are infrequent and there is no emergency overflow protection.

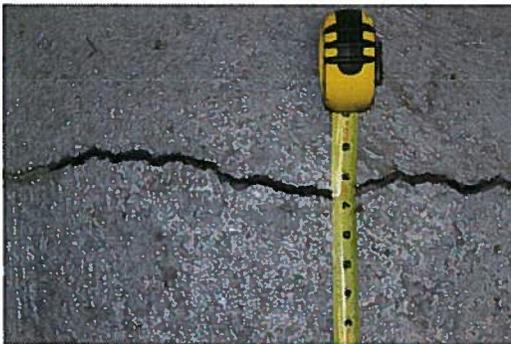
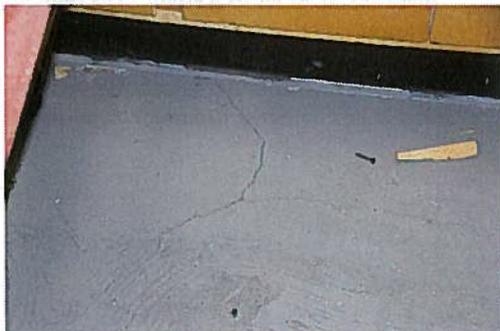
There is a significant crack in the concrete floor slab on the second level, within Room 203B. This crack runs the full length of the room and branches in multiple directions at the ends.

There is no misalignment or settlement of the slab. This crack should be repaired using a structural epoxy.

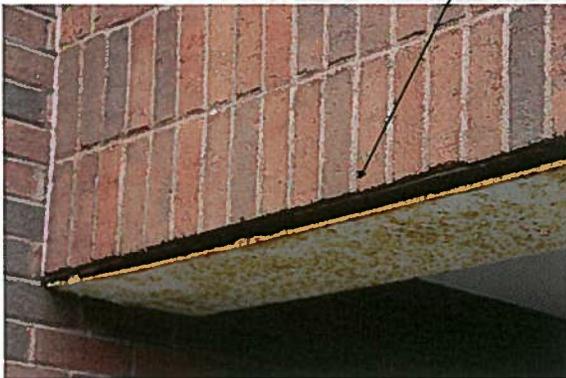
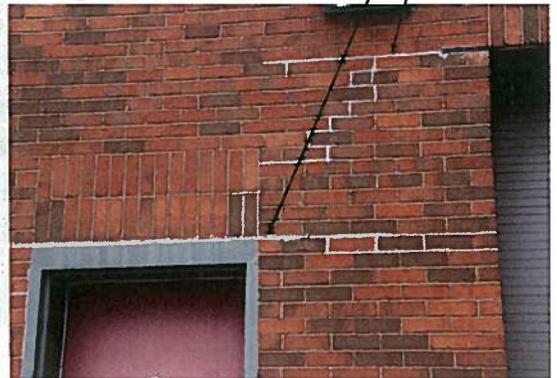
Also of concern is an apparent lack of flashing and weeping at interruptions and plane changes in the masonry. The steel lintels over the recessed entries are in complete failure. Damage to brick at door heads are also a result of a lack of weeping.

Damaged brick and failed steel lintels due to missing or insufficient flashing and weeping.

1. At the 1977 masonry walls, clean out weep holes.
2. At pilaster copings at gymnasium, install flashing over the joint between coping and stone.
3. Replace steel lintels at recessed entries. Soldier courses of brick should be removed and rebuilt with proper flashing and weeping.
4. Reseal all control joints.
5. Remove soft joints at stone lintels, sills and accents and install masonry mortar.
6. Remove rusting window security screens and clean masonry. If screens are required, either prepare, paint and reinstall, or provide new aluminum screens.
7. The membrane roof requires seam and flashing maintenance.
8. Sealant should be replaced around all windows, doors and openings.

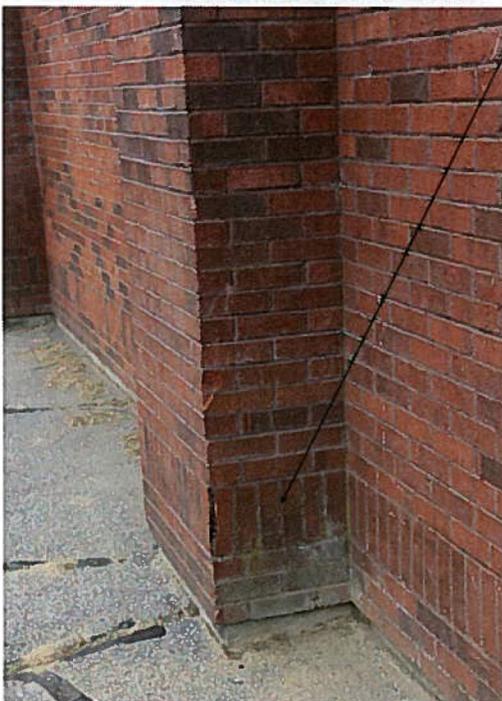
Damaged Masonry at base of Pilaster with no Apparent Weeping

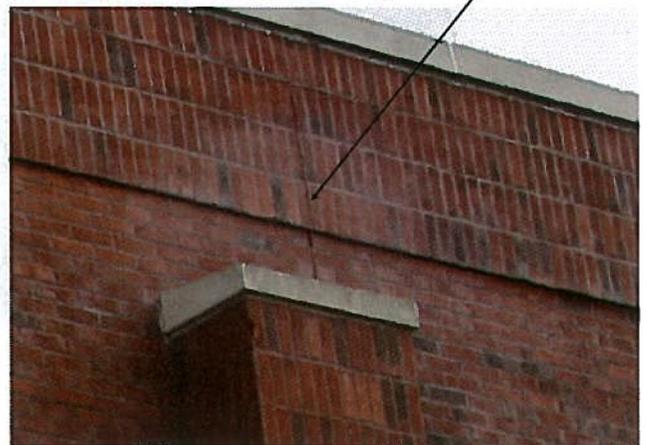
Control Joint with Failed Sealant

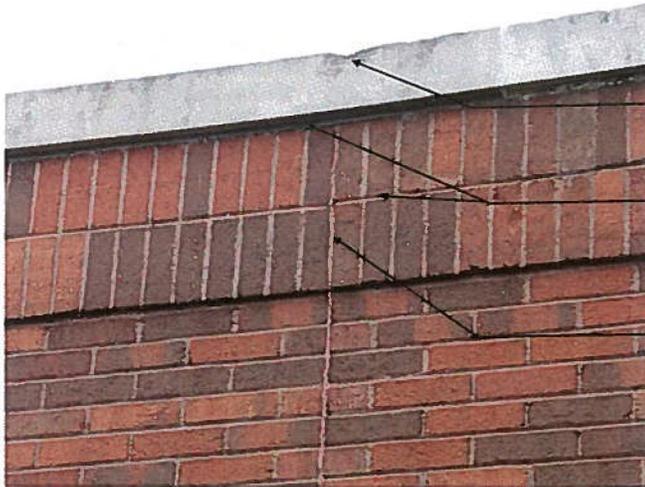
1977 Construction (Typical Conditions):

Cast-stone coping showing signs of damage.

No visible signs of flashing / weeping below coping or below soldier joint as detailed on original drawings.

Failed control joint sealant.

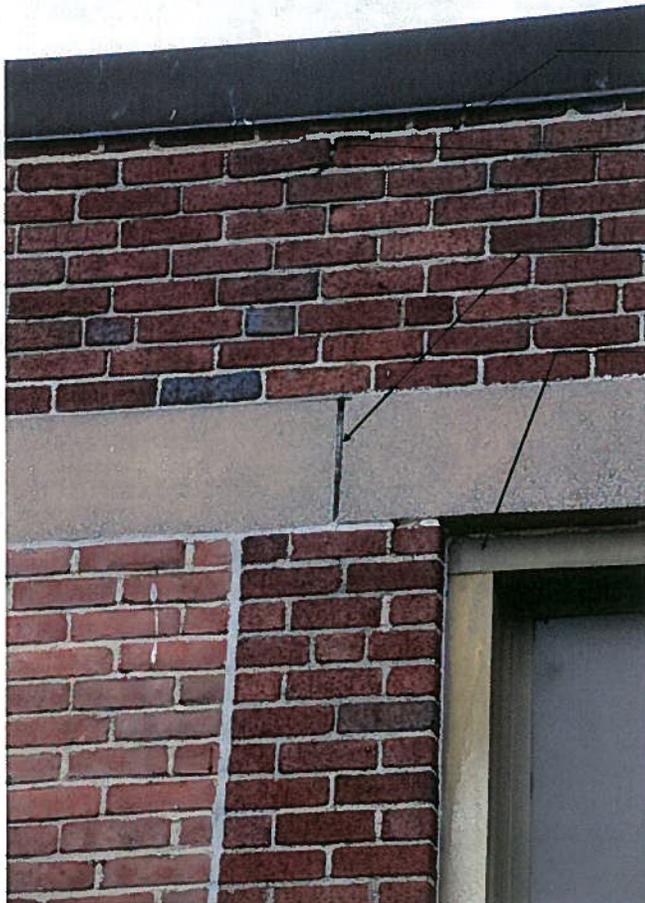
1944 Construction (Typical Conditions):

Masonry joints are deteriorated and in need of repointing throughout the wing.

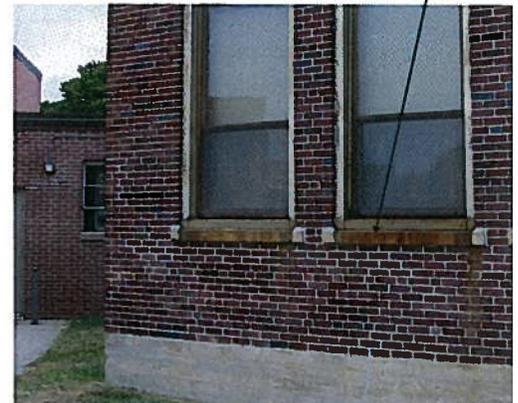
There are broken bricks in some locations, but this is not widespread.

Open joints in lintels allow water infiltration.

Aluminum windows are weathered.

Metal screens are rusting and staining masonry, which accelerates damage.

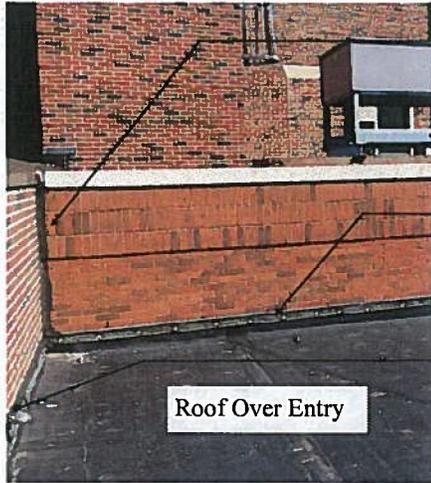
Building expansion joint should have a pre-manufactured joint system to maintain a water-tight joint.

Retainer bar and sealant at transition at north wall requires just routine maintenance.

Retainer bar and sealant at west wall appears to have failed and is coated with mastic. Bar should be reset and sealed properly.

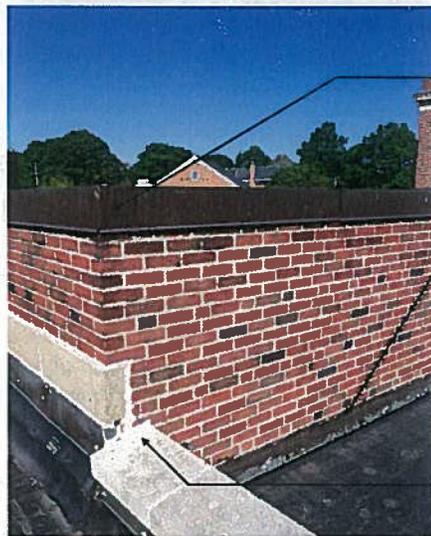
Maintenance required on roof-edge metal and roofing seams.

Mastic at top of retainer bar should be removed and retainer bar and sealant reinstalled.

Copings should be properly flashed and joints repointed.

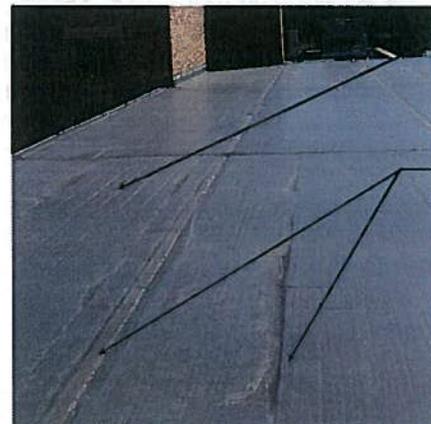
Roof is adhered using ribbon adhesive as opposed to full adhesion. Wind uplift requirements may not be achievable as installed (120 MPH).

Seam maintenance is required throughout the EPDM roof. It appears that joints in the rigid insulation below the membrane are not tight and the joints are telegraphing through the roofing, reducing the energy efficiency of the roof system.

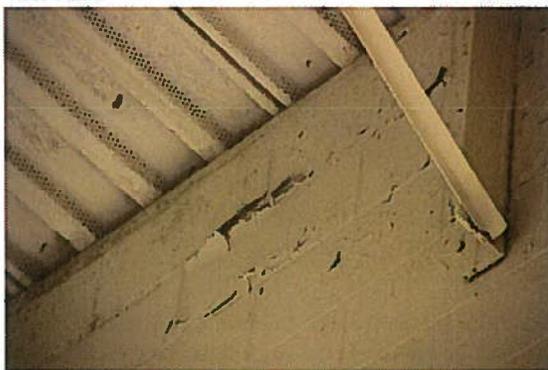
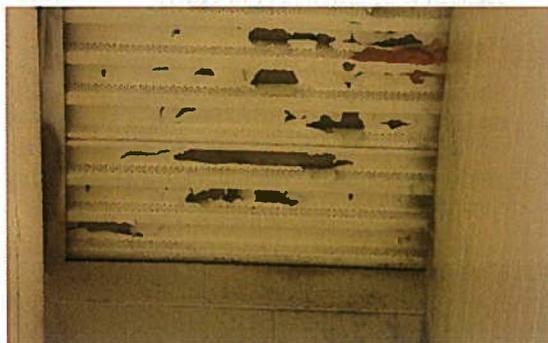
The gymnasium is the largest volume within the B-Wing and consists of an 84-foot basketball court with a hardwood floor. The floor is in generally good condition, though there is some damage from water or moisture at the east end.

There is evidence of water or moisture migration at the masonry walls. Damage is evident primarily high on the wall, and is likely a result of moisture migration through the cast-stone wall coping. The original construction drawings show through wall flashing, but without weeps at the termination of the flashing. It is also possible that the flashing was damaged in the re-roof in 2001, or that penetrations of stone dowels are not properly sealed.

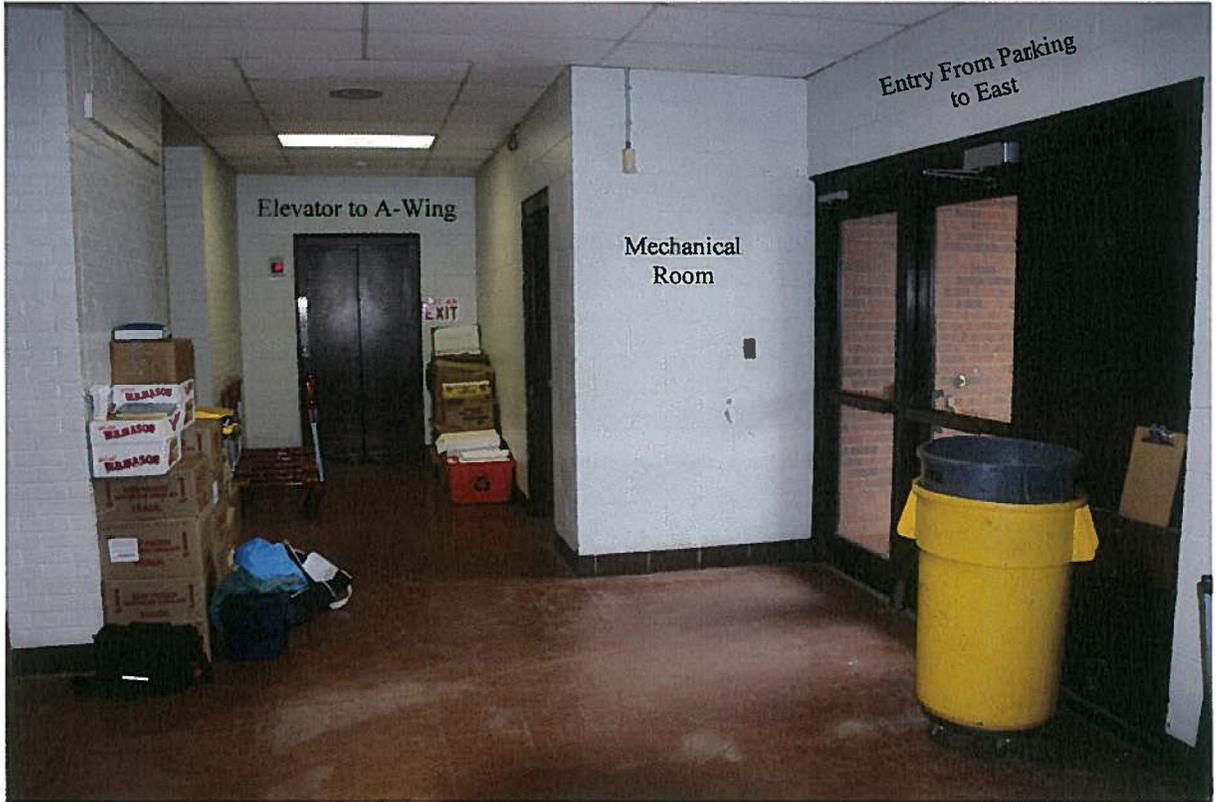
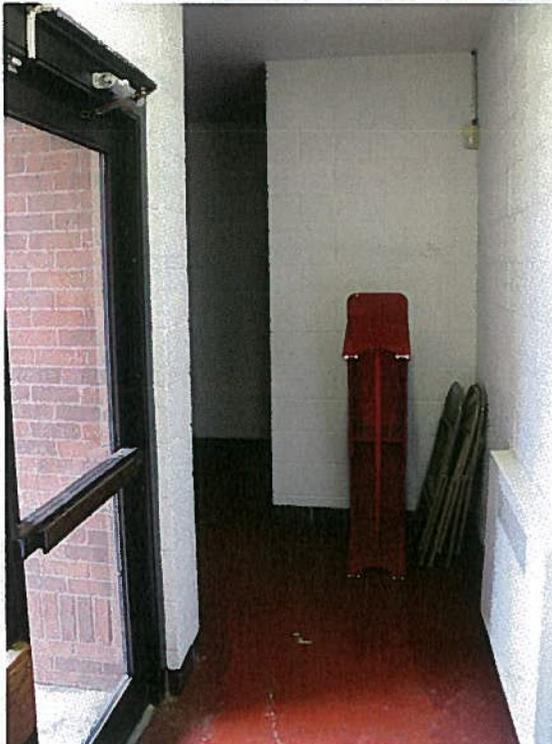
All floors are VCT and vary in condition. Heavy use areas are worn, in some places to the point of complete failure.

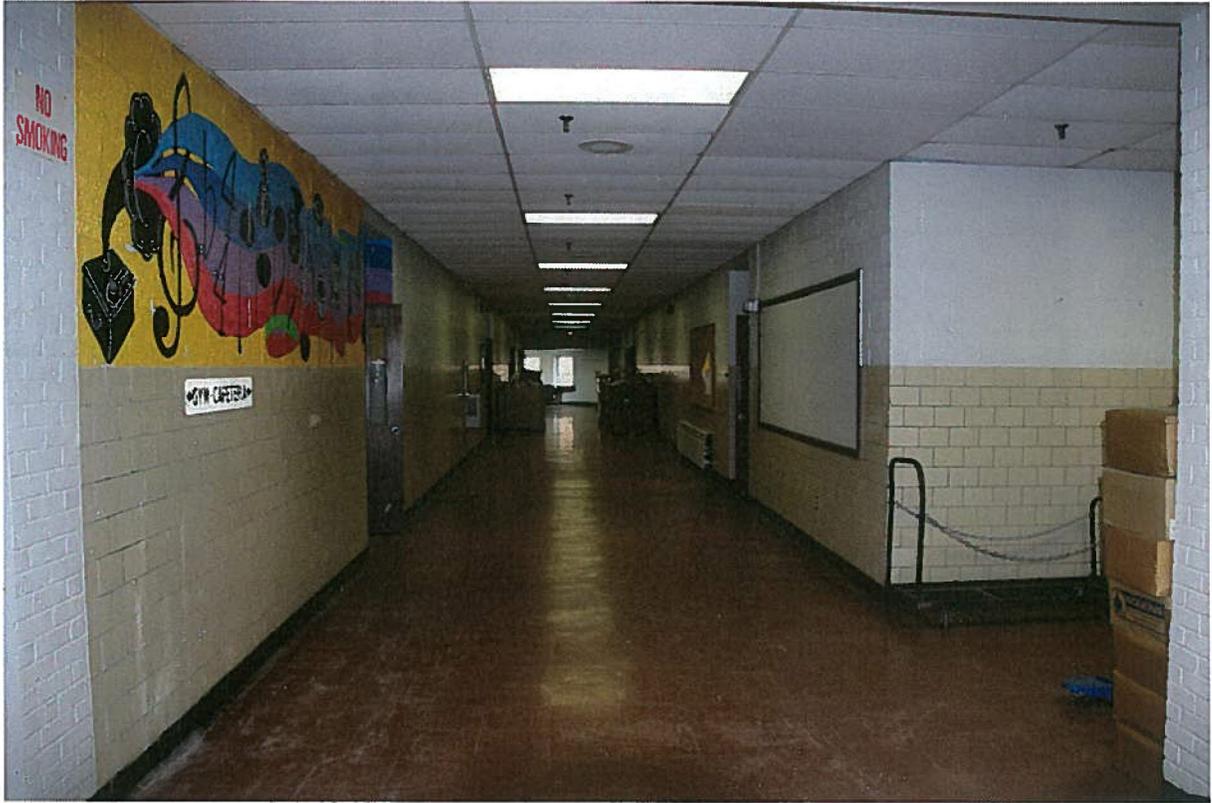
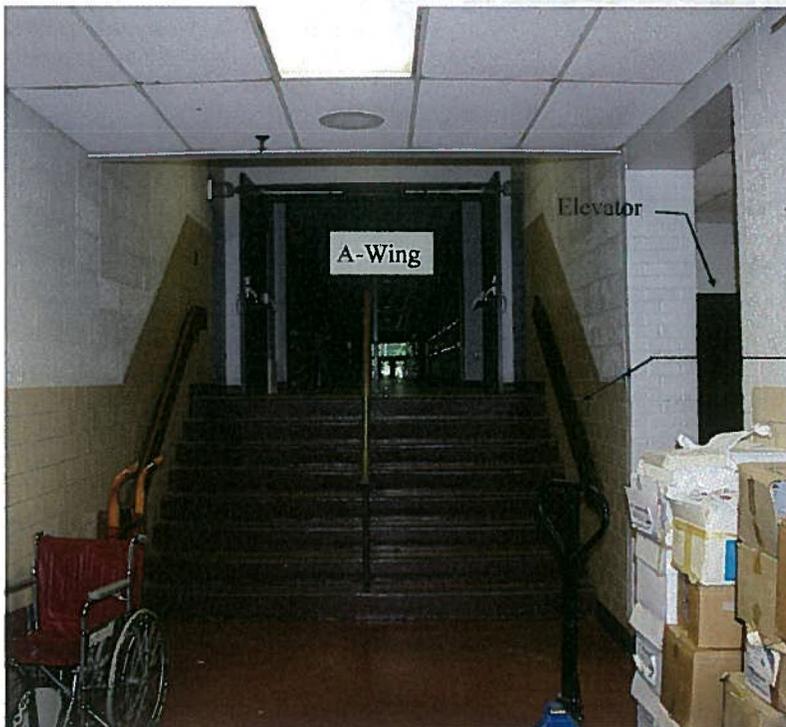
Handrails at the stair are not Code compliant

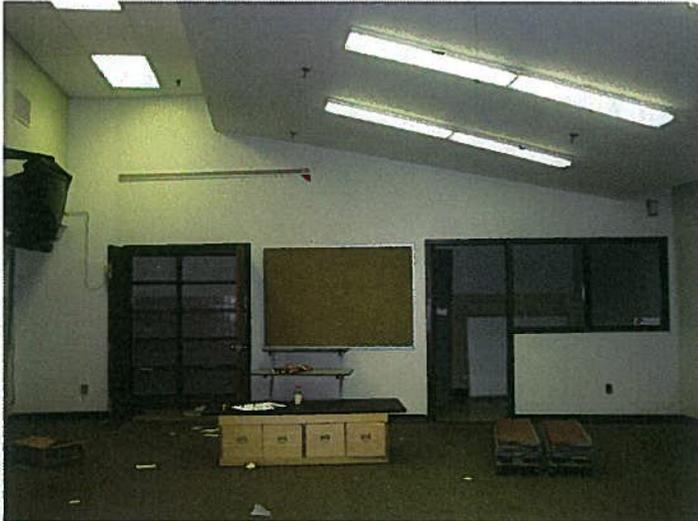
The music room has painted GWB walls. Ceilings are suspended GWB and acoustical tile. The floor is carpet which is worn and requires replacement.

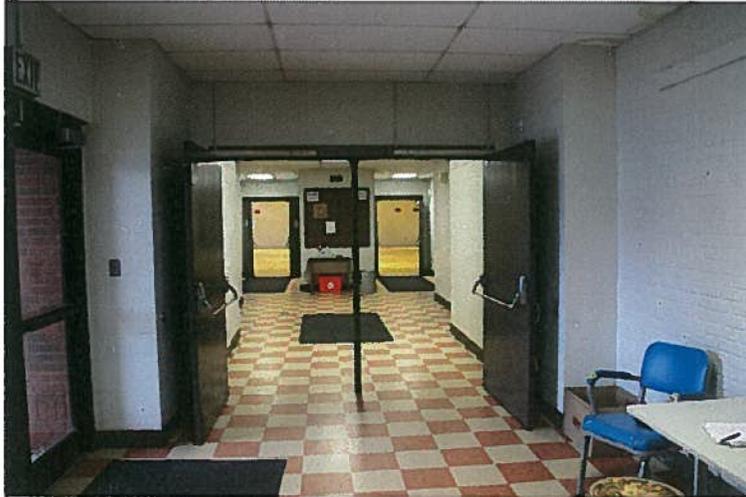
The configuration of the wall and the penetrations through the wall are non-compliant and will require properly designed and UL listed through-wall penetrations for compliance.

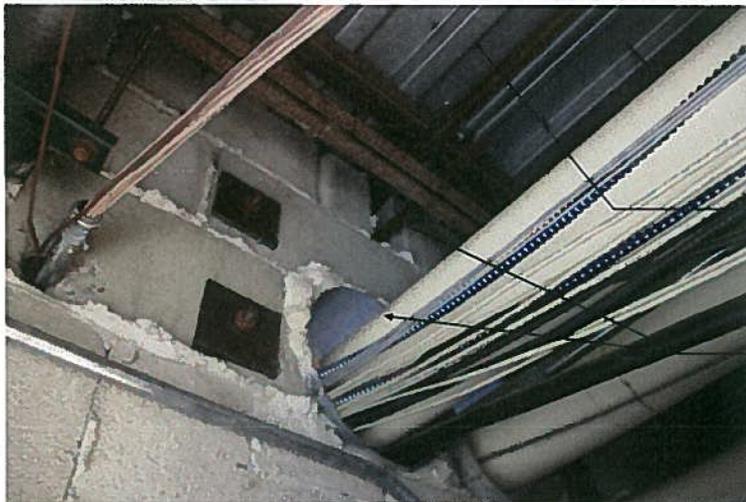
Metal deck with polyiso insulation do not provide the required fire resistance rating at the roof level.

Non-compliant through wall penetrations.

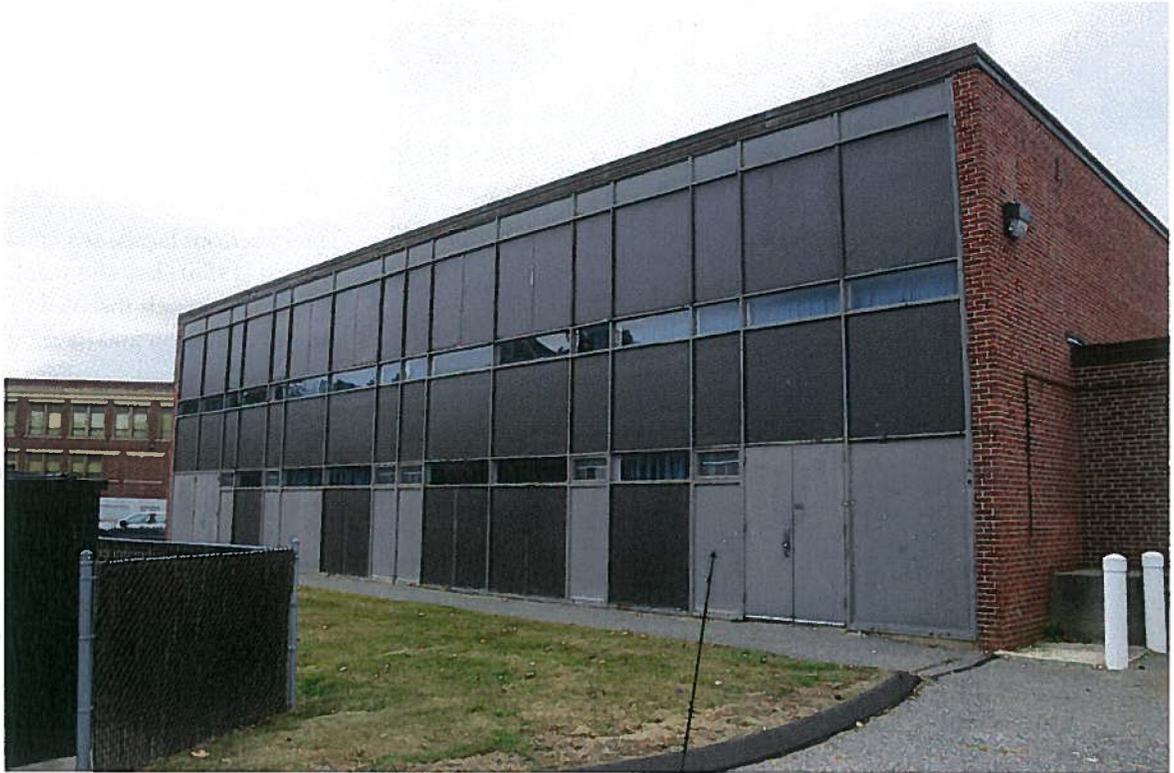
West Façade of Cafeteria

The west façade of the Cafeteria is a metal storefront system. It is heavily weathered, thermally inefficient and unattractive. As it is a prominent façade in the backdrop of the historic Town Hall, it would be prudent to make improvements to wall assembly.

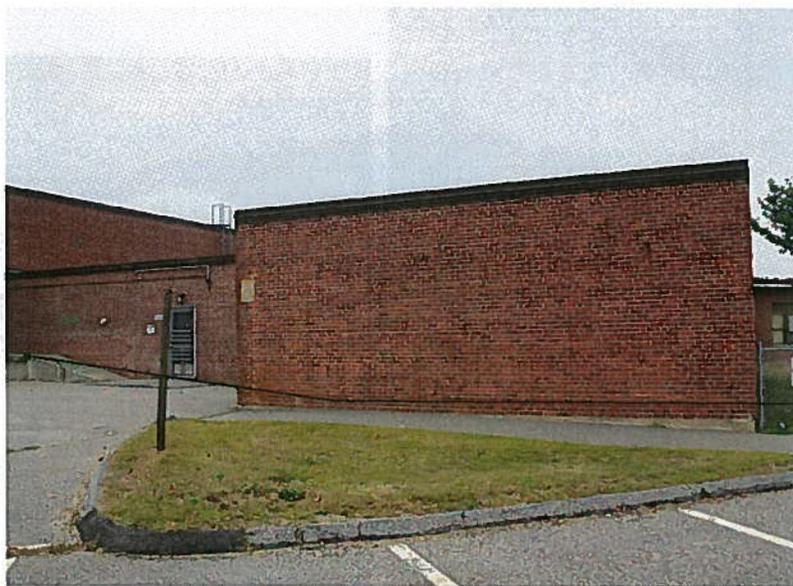
West Façade of Kitchen and C-Wing Classrooms

The Kitchen is served by bottled propane, which sits on a platform outside the west wall. In a renovation scheme, this should either be eliminated or better protected.

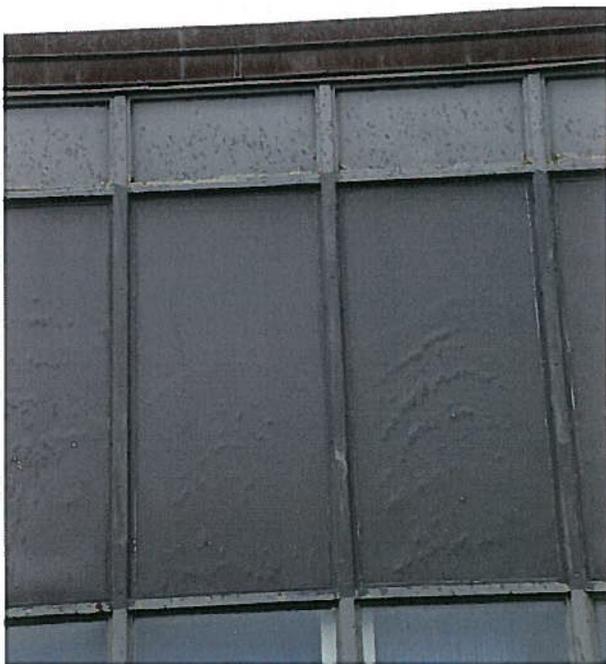
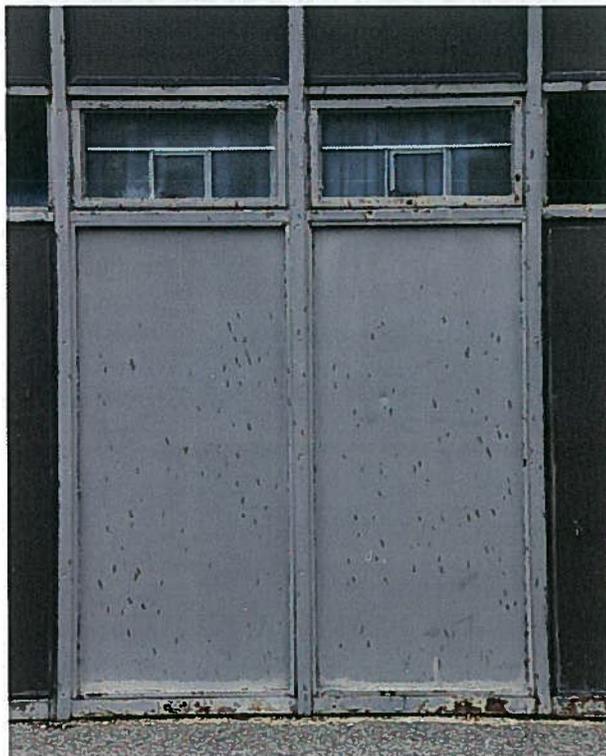
Detail—West Façade of Cafeteria, Near Top

Detail—West Façade of Cafeteria, Near Bottom

The storefront façade is a combination of original (1955) glass and insulated panels, as well as glass panels installed in 1977. All are in poor condition and have outlived their useful life.

The western exposure makes this type of system hard to control, resulting in glare and excessive heat gain in the cafeteria.

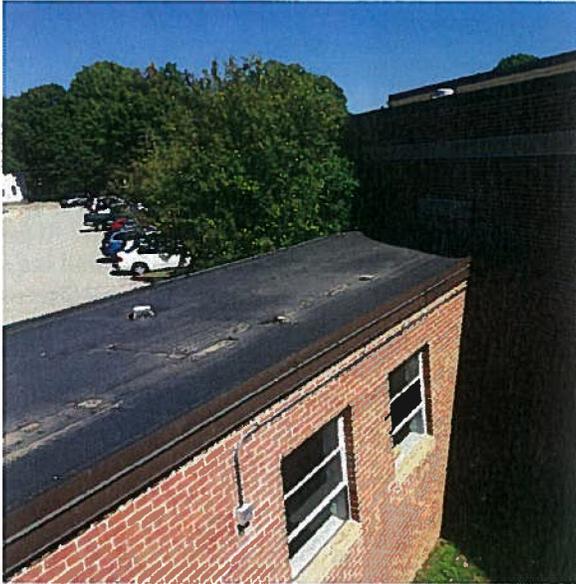
The roof over the connector is a mechanically adhered EPDM roof in generally good condition. It requires regular maintenance of seams and flashings. The connector was constructed in 1977.

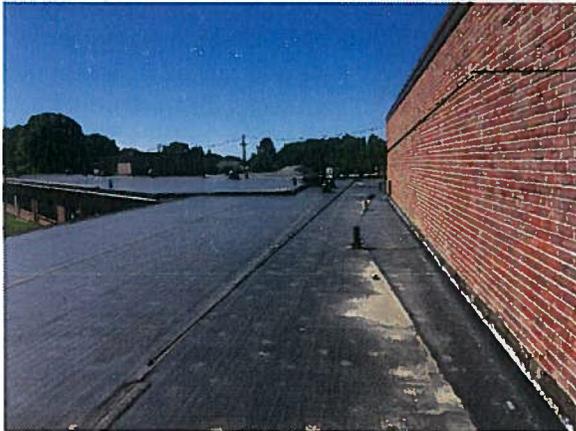
The roof over the classrooms and kitchen is a ribbon adhered EPDM roof on rigid insulation. There are several misaligned boards and many seams that are in poor condition. The roof is in need of significant maintenance.

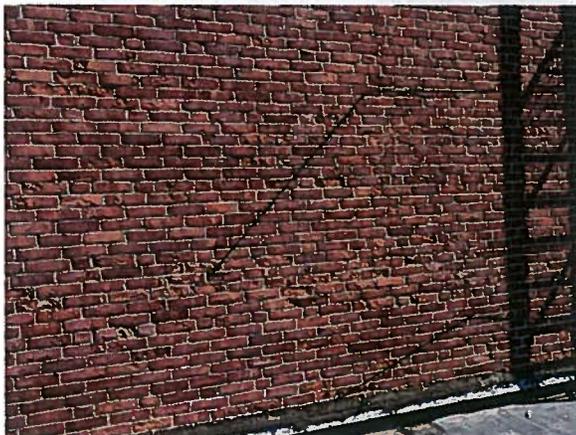
The brick at the cafeteria wall is severely weathered and in need of maintenance and repair. It appears that any weeping at the base of the wall has been covered by mastic and as such the wall cannot properly dry out.

Flashing to the cafeteria wall is failing and in need of replacement.

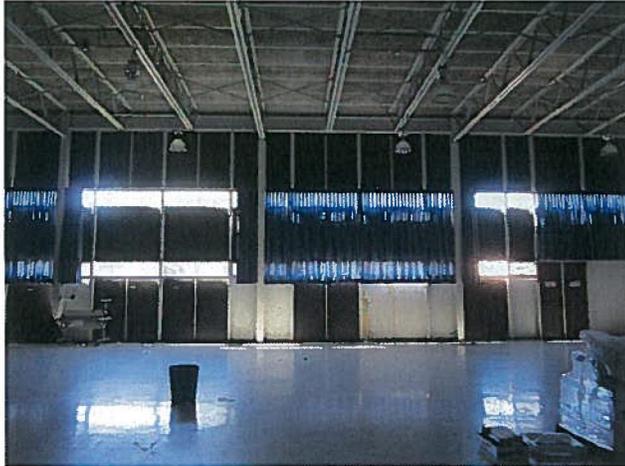
The cafeteria is a double-height space that is functional, but worn and in need of a finishes upgrade. The west wall is a storefront system that is in need of replacement. The flooring is VCT. There is no ceiling and the underside of the Tectum Acoustical deck is exposed above a steel structure.

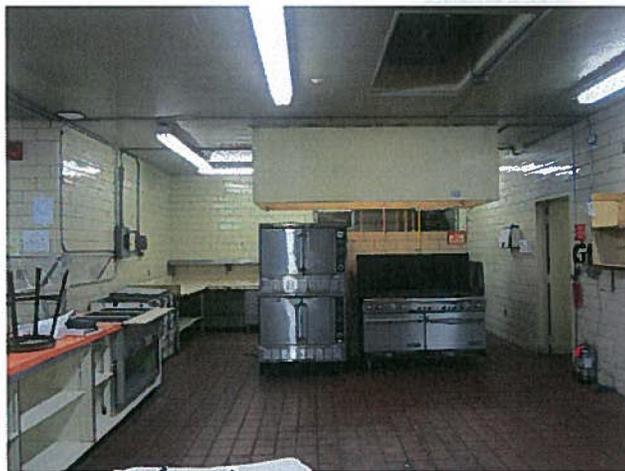
The hood and fire protection systems require verification, testing and certification before being put back in use.

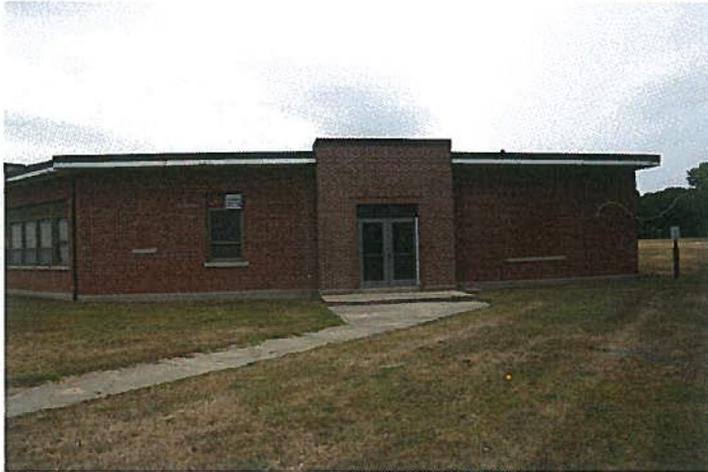
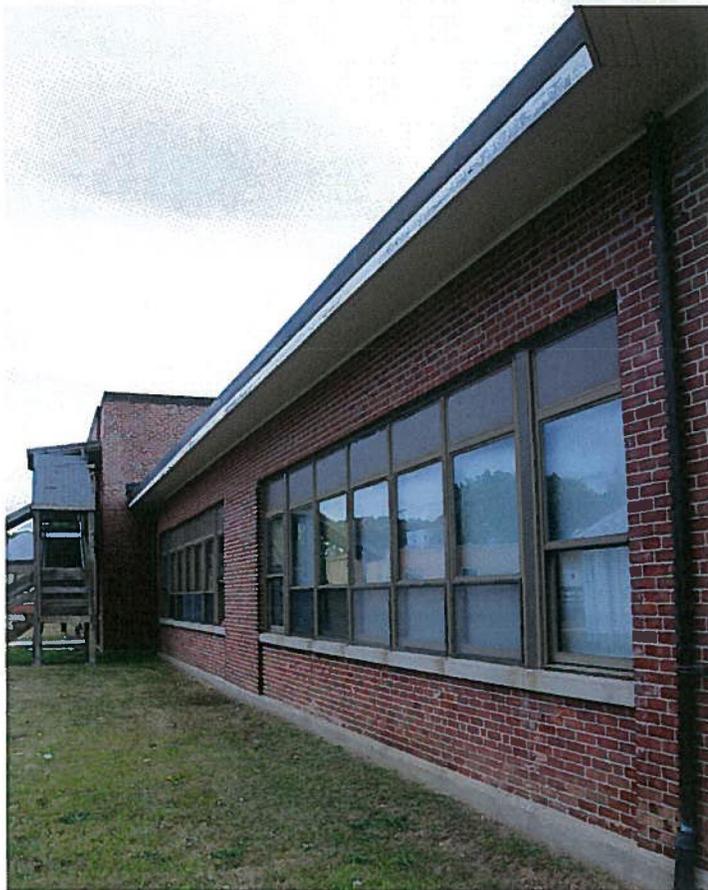
The roof overhangs the walls and is finished with a painted wood fascia and soffit. Roof edge metal terminates the membrane roof and laps onto the fascia. The wood components appear to be in reasonably good condition, but are in need of repair and repainting.

Originally, window openings were filled with 7-courses of glass block above a fixed-over-hopper steel window. The windows have been replaced with the current aluminum window system, which are worn and in need of full perimeter sealant, at a minimum, and likely full replacement if the wing is renovated.

The brick masonry veneer on the entire wing is heavily distressed and weathered. It appears that a coating or sealer was installed at some point to control moisture migration. This sealer may not be a breathable type of sealer and as a result may be trapping moisture and accelerating deterioration of the brick.

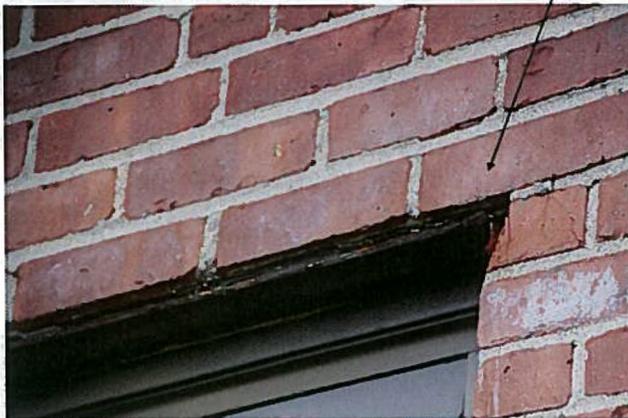
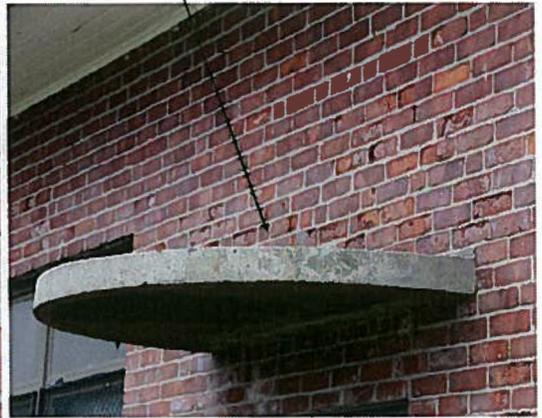
Rusted lintels and moisture migration have caused damage to brick at openings.

Cantilevered concrete canopy over doors are nearly flat and lack roofing or flashing. A bituminous coating has been added to control water penetration.

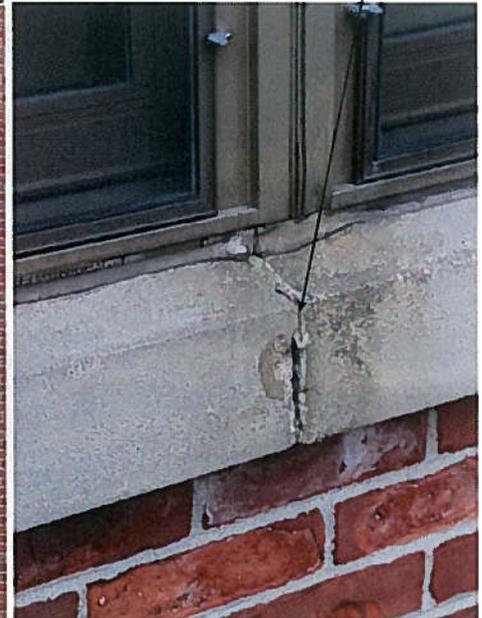
Heavily weathered brick and cracks that have been repaired are common on the D-Wing.

Failed joints at sills and at window perimeter allows water penetration into building and wall assemblies.

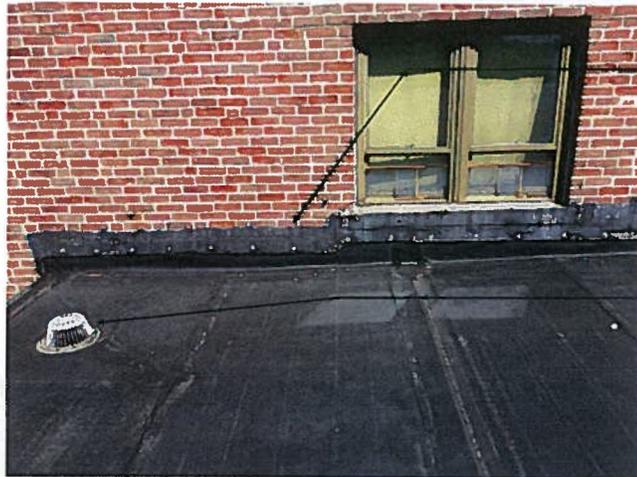
Flashing at the transition to the two story area is in need of complete replacement.

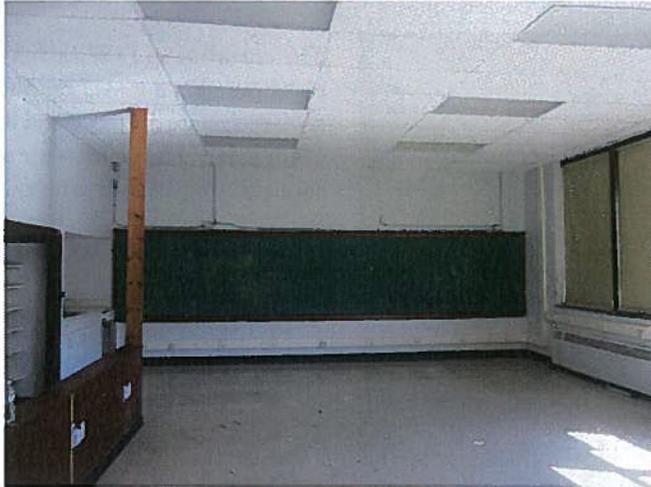
Typical finishes in D-Wing classrooms include painted plaster and GWB on walls, suspended acoustical tile ceilings and VCT floors. Most of the wing is slab on grade, though there is a pipe tunnel around the perimeter of the wing and a basement area under the two story portion.

There is evidence of moisture or water migration at the exterior walls, as finishes are damaged.

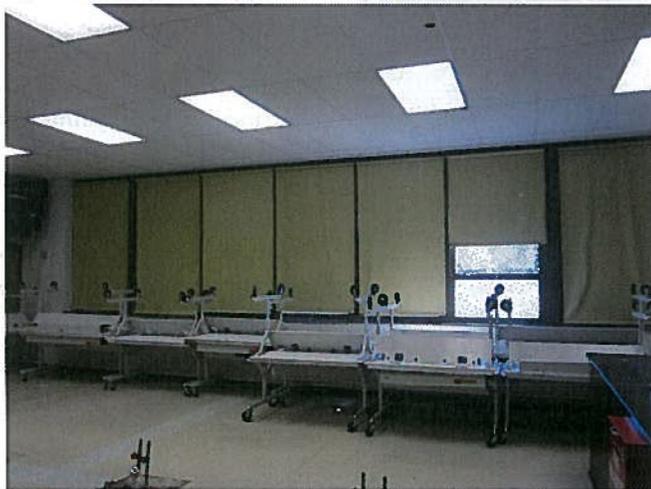
Several D-Wing classrooms are science labs, with laboratory casework. Some casework has been removed, leaving utilities stubbed up through the floor.

Windows treatments are in poor condition.

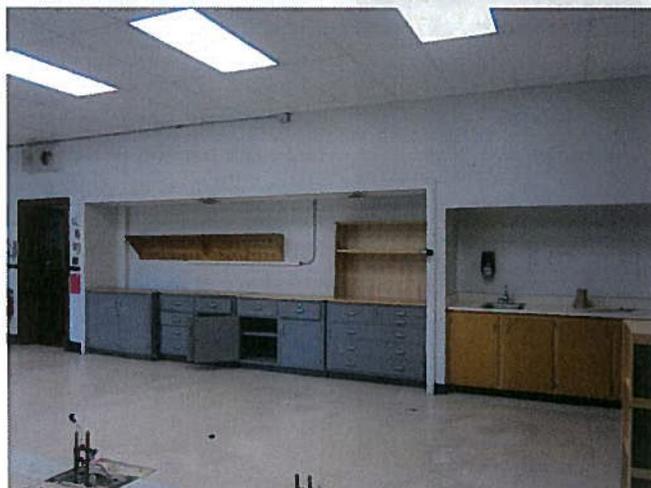
Casework is a combination of metal and wood and countertops vary from wood and plastic laminate to epoxy resin.

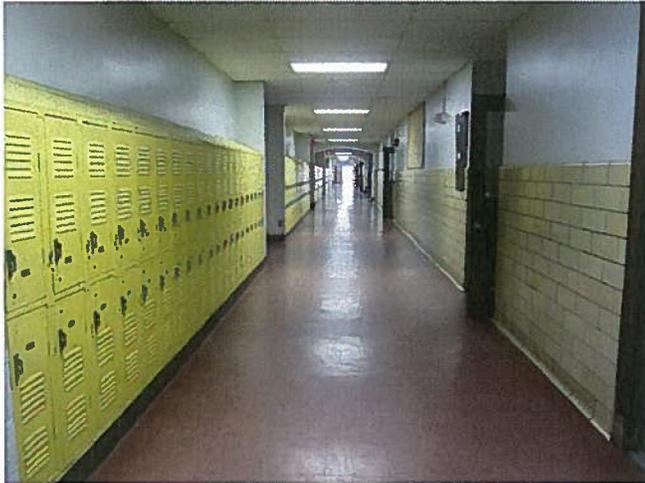
The corridors in D-Wing have painted plaster above glazed CMU on one side, and semi-recessed painted metal lockers on the other side. The ceilings are suspended acoustical tile. Floors are VCT.

Doors into each room are wood with hardware that is not HCA.

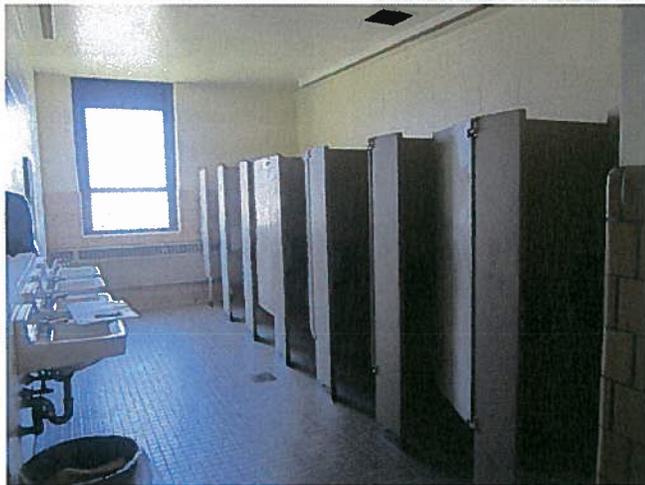
Toilet rooms have painted CMU walls in some locations and painted plaster above glazed CMU on exterior and corridor walls. Floors are ceramic tile.

The rooms are in generally good condition, but there is no handicapped accessibility.

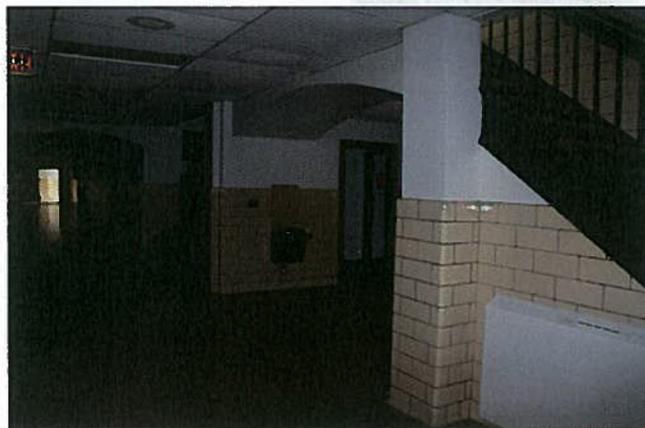
Access to the upper and lower level of the two-story portion of the wing is by means of stairs. There is no elevator access. The second means of egress from the upper level is through a door in the exterior wall, onto the wood exit stair. The door is in poor condition , as is the wooden exterior stair.

A wood exterior fire escape was constructed to provide a second means of egress from the second level of D-Wing. This stair is in generally poor condition and is not compatible with the architecture of the building. If continued use of the second floor is planned with a use that requires two means of egress, then this stair should be replaced with a new fire stair.

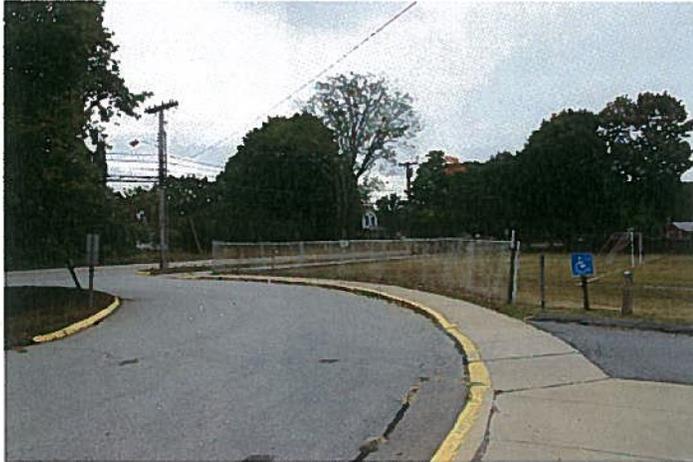
Driveways, sidewalks and parking areas are in varying conditions, but all are in need of basic maintenance, such as crack sealing, pot hole repair and repair of sunken areas.

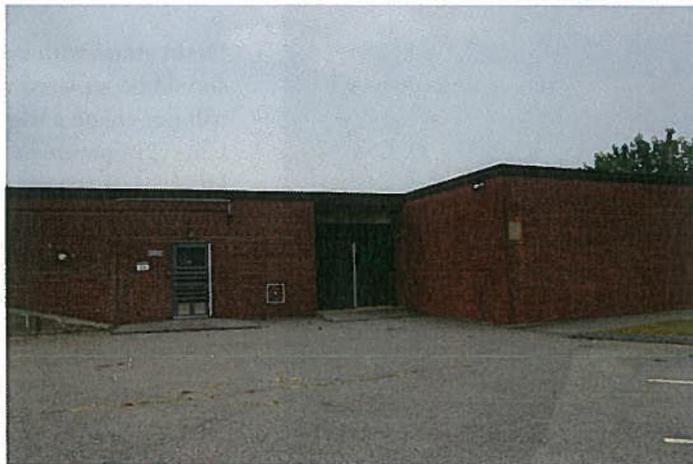
Much of the building has pavement right up to the foundation walls. Pavement should be removed from the building, as it promotes damp-rise, which stains and damages the concrete and brick. Grade should be held down several inches below the bottom of brick. Ramped access has been installed to many of the door openings, but most are not HCA and many create a tripping hazard. They are also not constructed with a level landing as required.

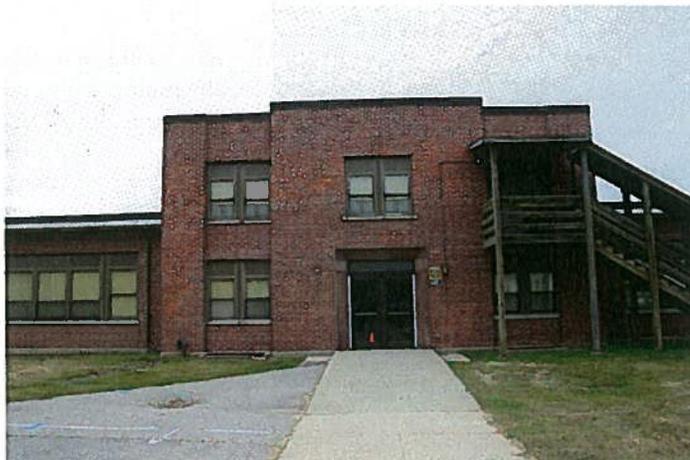
At the entrance to the D-Wing on the west side, a concrete sloped concrete walk was placed over the top of the existing landing. A bituminous paved area connecting this walk to the entrances to the portable classrooms is in poor condition and should be removed once the classrooms are removed.
