BUILDING CONDITIONS ASSESSMENT  
*for*  
Fitch Middle School  
Town of Groton, Connecticut

*Architect:*

TLB Architecture, LLC  
92 West Main Street, Chester, Connecticut 06412

February 27, 2015

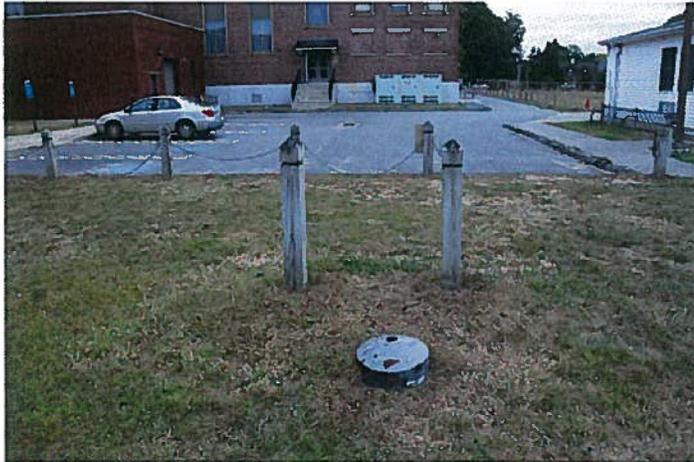
The bollards protecting the buried gas tank should be replaced with more substantial bollards as the wood posts would not be capable of stopping a vehicle.

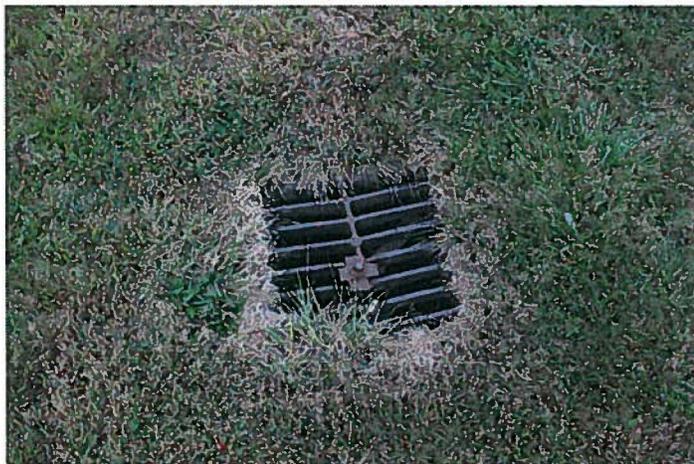
Drain grates with large openings should be replaced with covers that will not create a tripping hazard. Covers in pavement should be HCA.

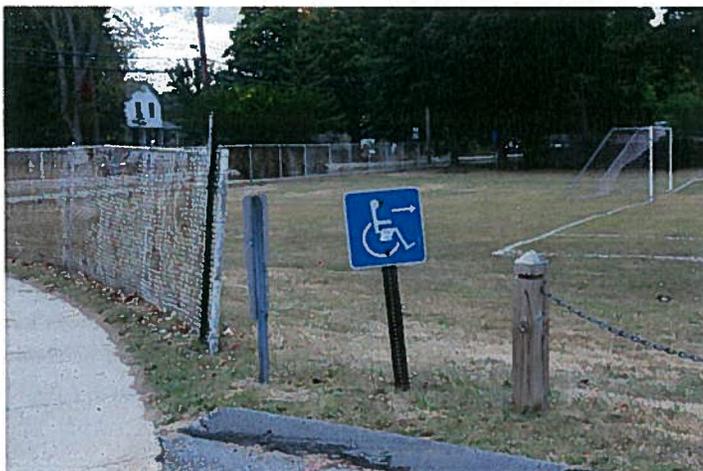
Site fencing and signs are in generally poor condition. Much of the signage is not ADA compliant.

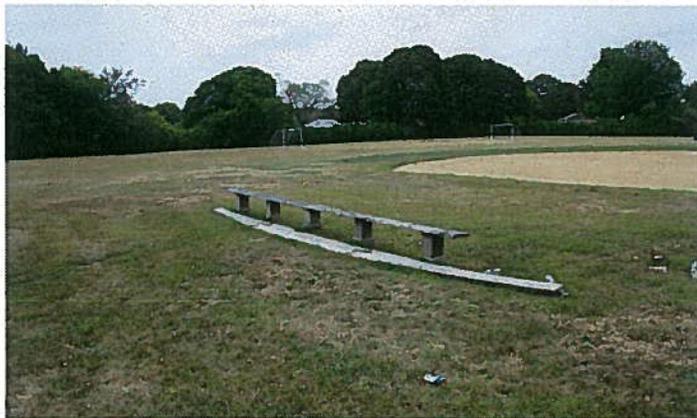
Ball fields are playable but depending on the desired level of quality, can benefit from a turf management plan and irrigation. Lips at the transition from infields to outfields should be leveled to avoid trips and bad hops.

Ball field and site accessories, including benches, bike racks, soccer goals, field hockey goals and lacrosse goals, trash bins, picnic tables, etc. are in need of repair or replacement.

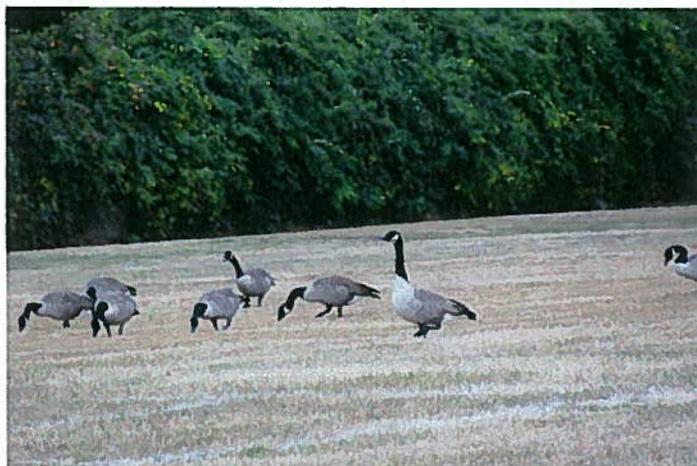
Geese create a nuisance and a potential health hazard from the droppings.

CT DEEP offers some guidance on dealing with geese, but it remains a significant challenge. Guidance can be found at the DEEP website.

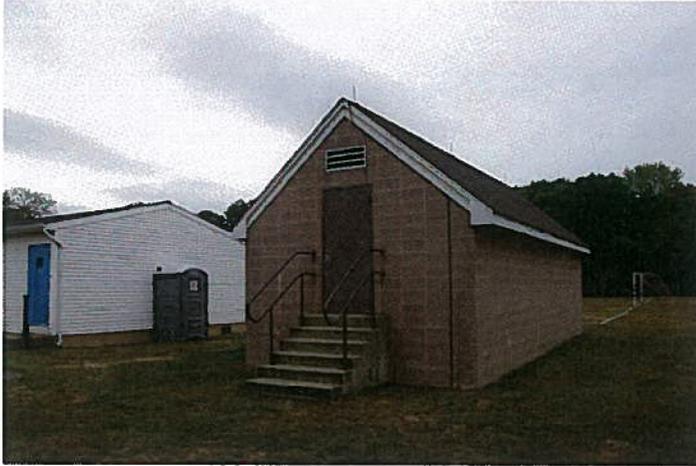
An elevated masonry fuel storage building is in good condition and its continued use is likely in any reuse plan.

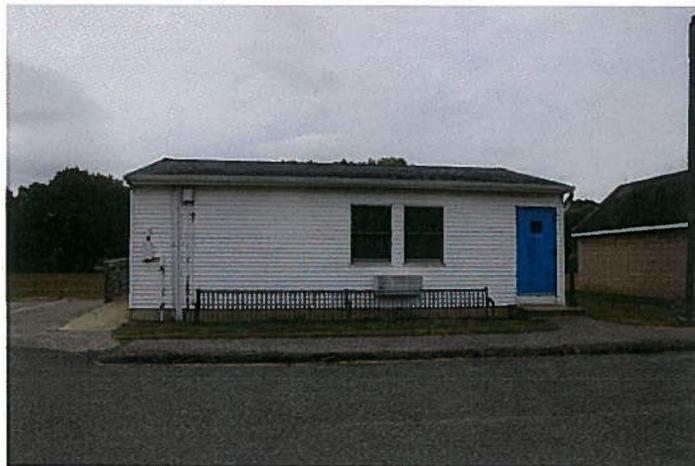
The Arts and Crafts building is a portable classroom-type building. It is serving its purpose and is in reasonably good condition. In the short-term, the building should continue to be serviceable. In the long-term, if the programs need to be continued, it should be moved into the main building, as the building has a limited anticipated life and is incompatible with the architecture on-site. The skirt at the foundation is damaged and should be repaired to prevent unauthorized access below the building.

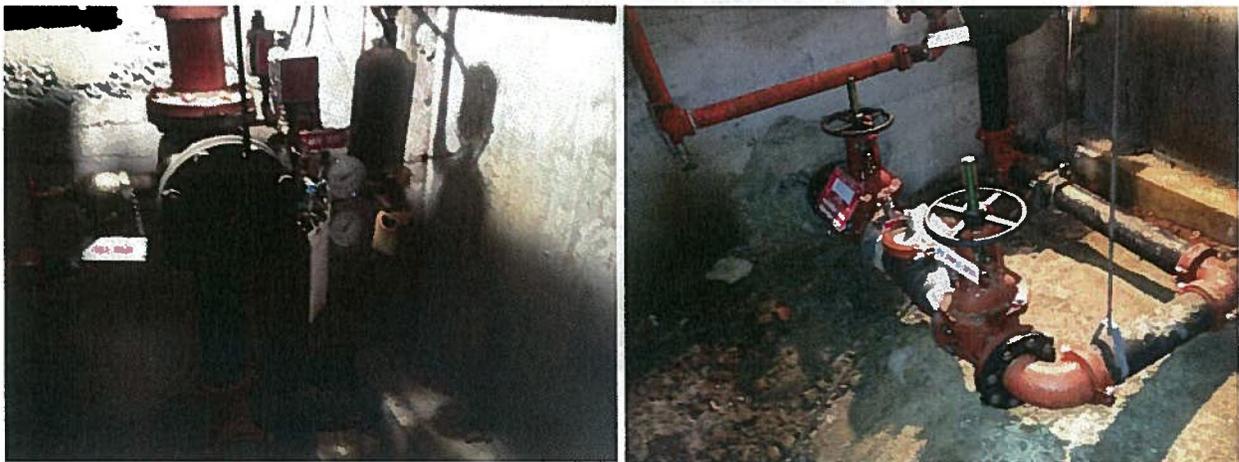
1. Existing Fire Protection Service: The existing building is currently served by a 6-inch fire protection service. The service is provided with a post indicator valve located on the side of the parking lot closest to Fort Hill Road. The service enters the building on the north side and into a crawl space below the first floor. This 6-inch main reduces to a 4-inch line at the foundation wall. All fire service equipment is 4-inch. Fire service equipment consists of an "Ames" 2000SJ double check valve, isolation valves with tamper switches, alarm check valve, water motor gong, test/drain connections and fire department connections.

2. Pressure gauge readings on the street side are 95 psig static and 120 psig on the system side.
3. There are two fire department connections provided on the west side of the building. These fire department connections are building mounted 2 1/2x2 1/2x4 inch Siamese type connections.

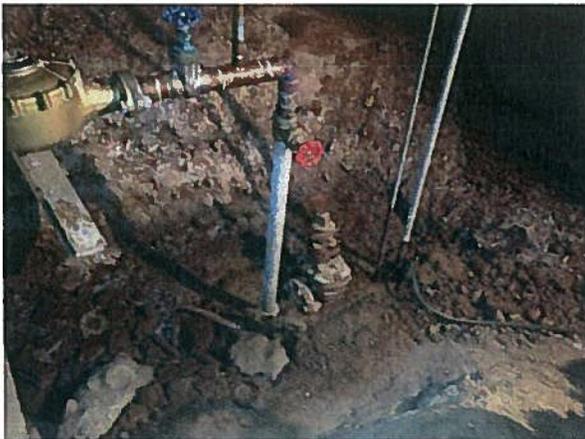
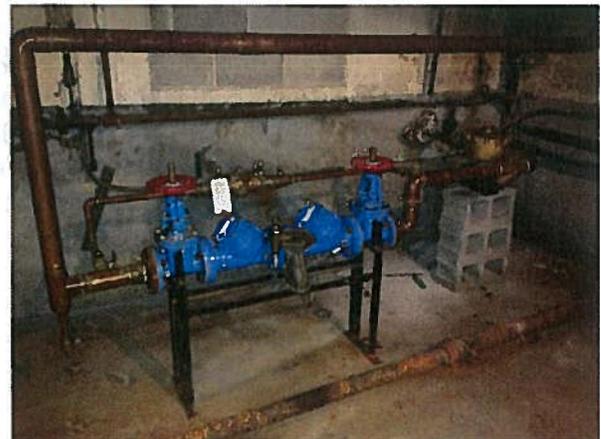
1. **Domestic Water Service:** The existing building is currently served by two 4-inch domestic water services. The first service enters the building on the north side from Fort Hill Road into the basement/crawl space. This service incorporates a 2-inch water meter, 1-inch bypass, pressure gauges, strainer and isolation valves. The second service enters the building on the west side from Depot Road into the basement. This second service incorporates a 2 ½-inch water meter, 1 ½-inch bypass, pressure gauges, strainer and isolations valves. Both services incorporate a reduced pressure backflow preventer on both the main service line and the bypass. These two water services currently serve all of the buildings domestic water needs.

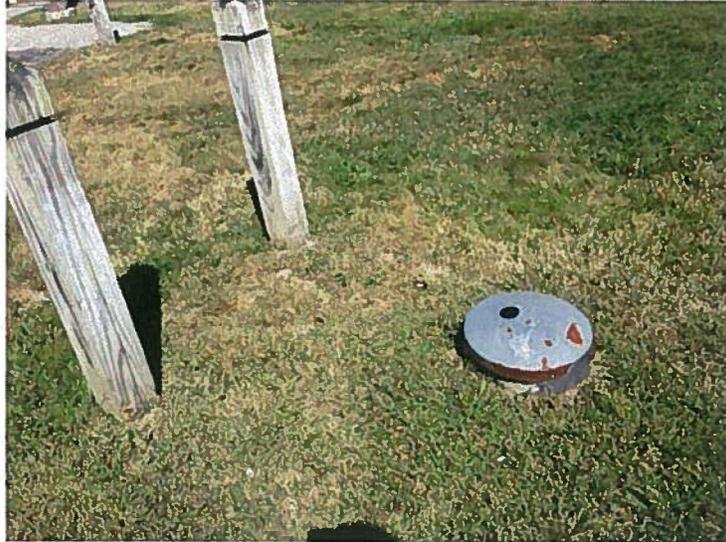
2. **Propane Gas:** There is currently a buried propane tank located on the east side of the building. The tank size is unknown. The gas line enters the building on the east side and incorporates a pressure regulating valve located on the building exterior. The age of the tank is unknown.

1. Remove the buried propane tank and provide as required for any new gas fired equipment.
2. Have all buried sanitary waste and storm piping pressure tested and scoped to determine the condition of the piping for reuse.
3. Remove all vitreous china plumbing fixtures and install new water saving low flow fixtures. Provide ADA accessible fixtures in locations requiring these types of fixtures.
4. Remove the domestic hot water storage tank, heat exchanger and tankless water heater and provide new high efficiency gas fired water heater. Size to be determined based on the renovation work and the requirements for domestic hot water.

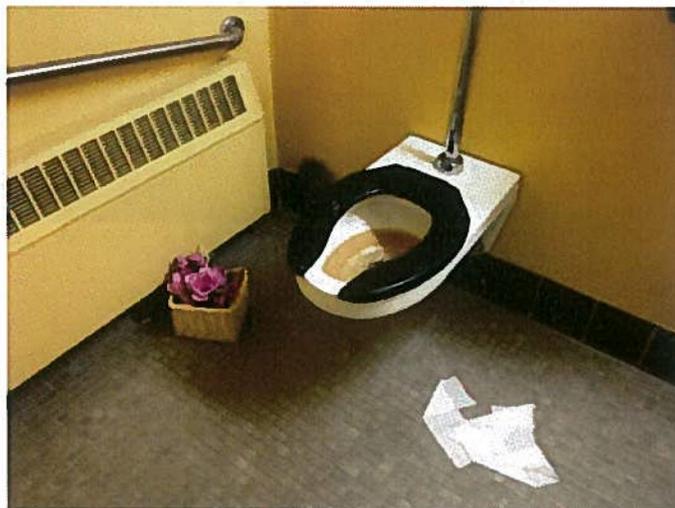
1. Water closets are vitreous china, floor mounted and wall hung with manual flush valves. Flush valves are not water saving type. None are ADA compliant.

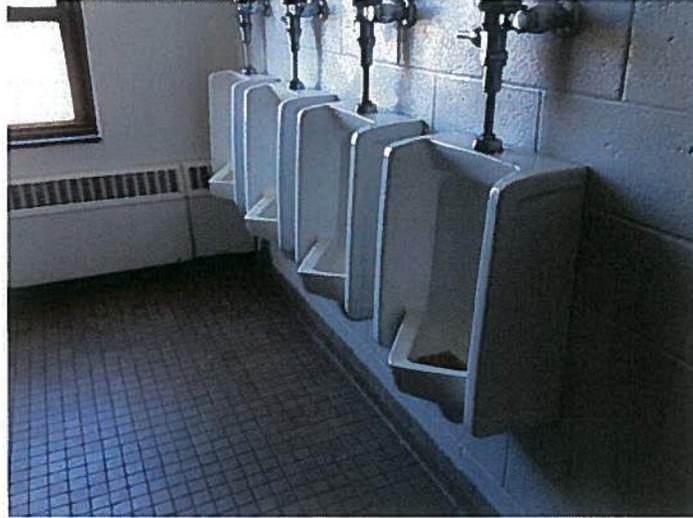
2. Urinals are vitreous china, wall hung with manual flush valves. Flush valves are not water saving type. None are ADA compliant.

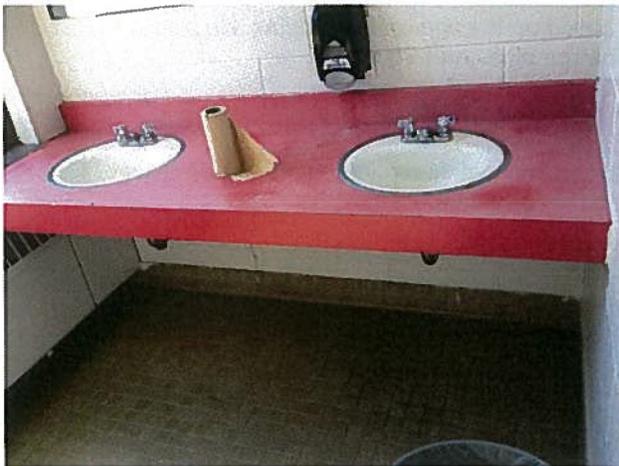
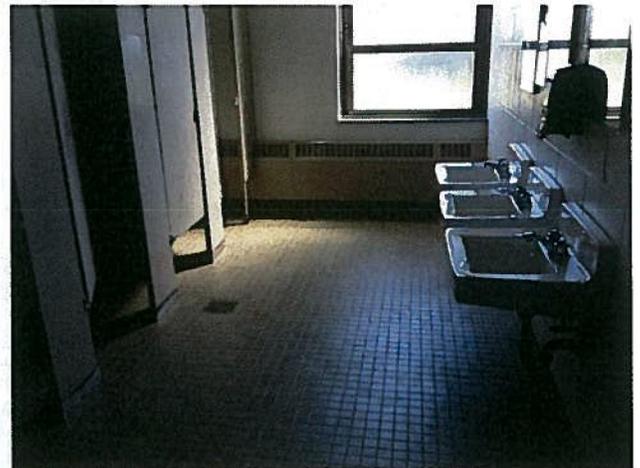
3. Lavatories are vitreous china wall hung and countertop mounted. Faucets are both two lever type and single lever type. Faucets are not water saving type. None are ADA compliant.

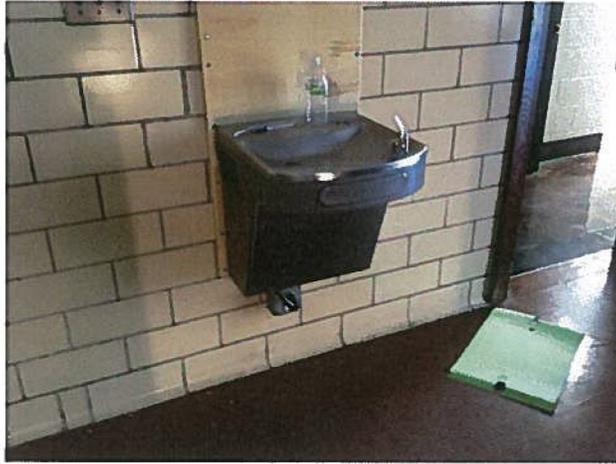
4. Drinking fountains are wall hung stainless steel, some are semi-recessed. There are only a few ADA compliant drinking fountains located throughout the building.

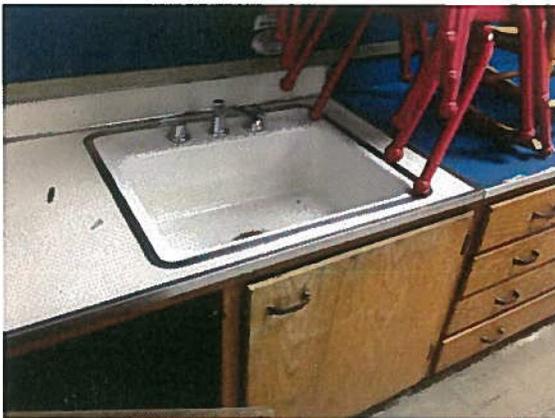
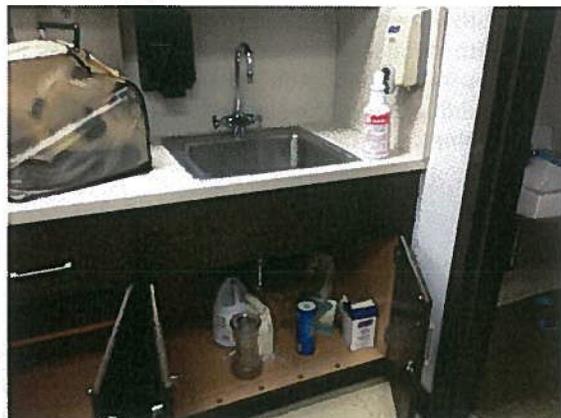
5. Classroom sinks are enamel coated cast iron with two-lever faucets, none are ADA compliant. Some classroom sinks are stainless steel countertop type with two lever handle faucet and gooseneck spout. All are provided with hot and cold water supply.

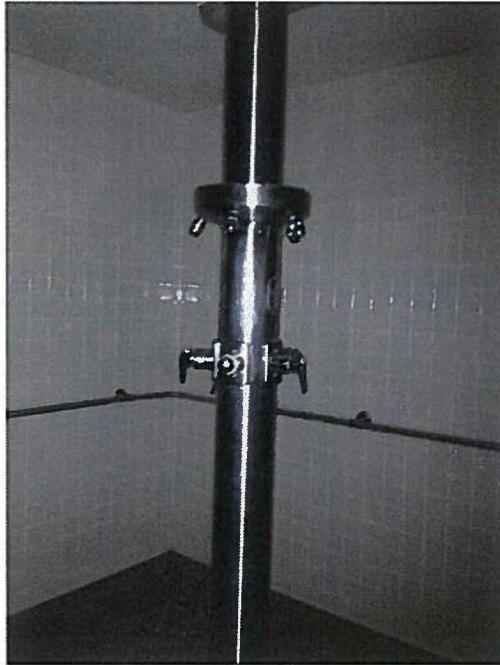
6. The gymnasium Locker Room is provided with gang showers that may not be compliant with the Health Code relative to the pitch of the floor and available drains. Gang showers are stainless steel pedestal type with drain at the base of the pedestal. The girl's locker room is provided with some shower stalls. The toilet fixtures and drinking fountain in this area are all non-ADA compliant. The coach's toilet rooms are provided with a toilet, lavatory and shower. Shower is a single 36"x36" terrazzo base with tiled walls. Shower valve and head are as manufactured by Symmons.

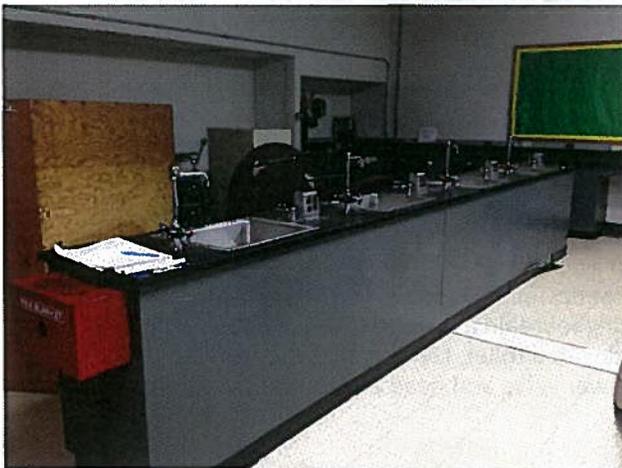
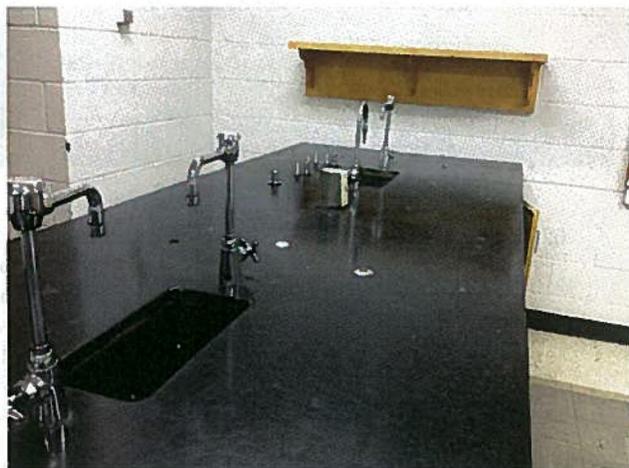
7. Science Classrooms. Emergency Eyewash stations at existing Science Classrooms are single plastic bowl type mounted at the end of the student work tables. Science classroom sinks are acid resistant solid surface integral to the countertop. Faucets are single lever type, gooseneck with integral vacuum breakers and have only a cold water supply. Some locations are provided with stainless steel countertop type sinks. None are ADA compliant. There is no acid neutralization system present for these fixtures. Three of the science classrooms located in Building D are provided with gas turrets piped to a master gas valve located in a recessed cabinet. Gas pipe in cabinet has been cut and gas pipe to turrets is not active.

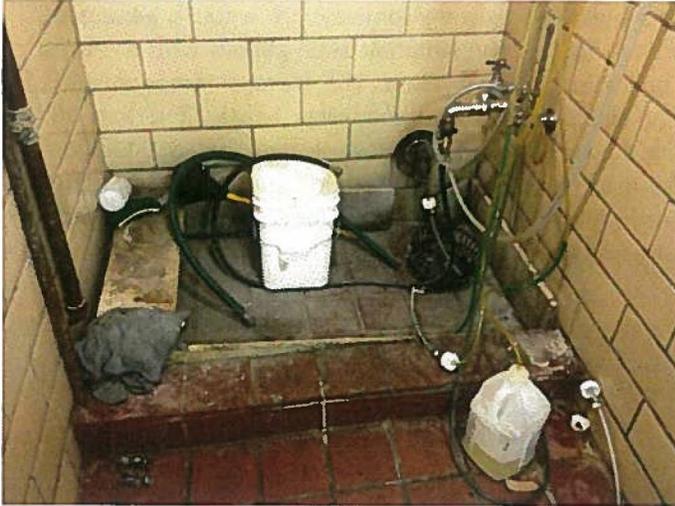
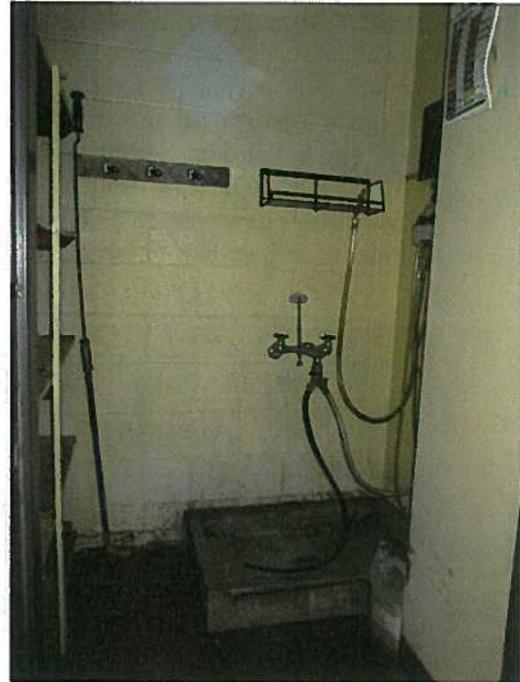
8. Mop Basins: The kitchen mop basin is floor mounted constructed of tile with a two lever service sink faucet with vacuum breaker. All other mop basins are 36"x36" terrazzo type with same faucet.

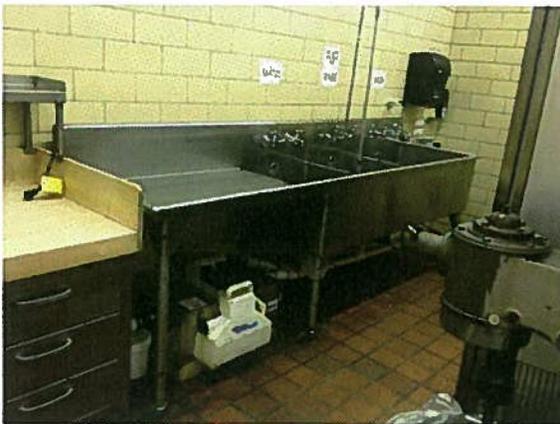
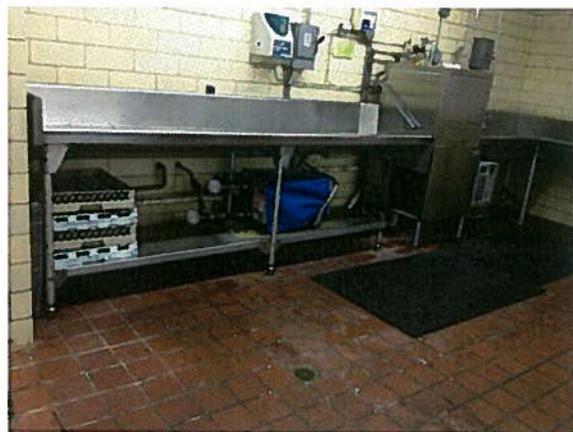
9. Kitchen Fixtures: There is currently a three bay scullery stainless steel pot and pan sink with an automatic grease recovery unit located below the sink. Waste pipe is hard piped. A commercial grade single rack dishwasher is provided and incorporates a pre-rinse bay with hose spray and electric booster heater. Discharge waste pipe is not provided with an air gap. Gas fired appliances are provided with a propane gas supply. Pipe material is corrugated stainless steel and is piped to an outside above ground propane tank. Hook up for propane tank is in place, but propane tank has been removed.

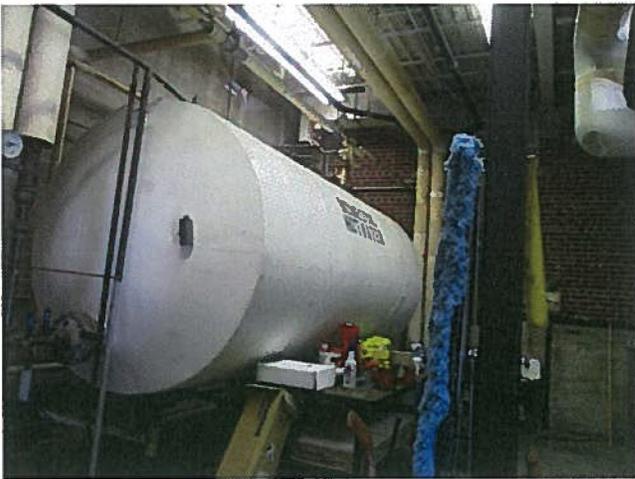
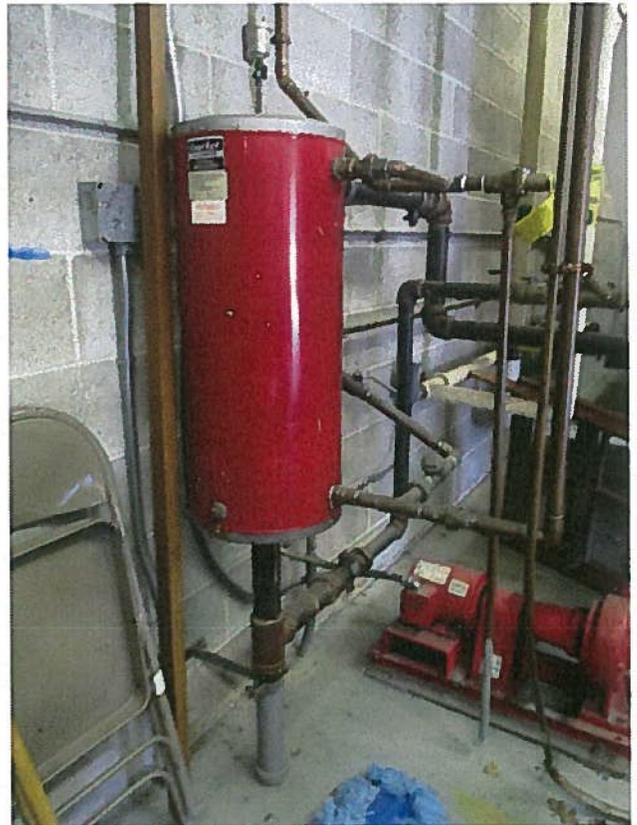
1. **Existing Domestic Hot Water System:** The building's existing domestic hot water is generated by a single horizontal storage tank estimated to be approximately 1600 gallons with a P-tube internal heat exchanger fed from the boiler hot water system. The storage temperature is unknown. This system also incorporates a single vertical tankless water heater "Everhart 20-LONG and is assumed to be utilized during the summer months. Both storage tank and tankless heater are over 30 years old. System also incorporates a hot water circulating loop and water recirculating pump located under the horizontal tank to ensure hot water is available in a timely manner to all plumbing fixtures that require hot water.

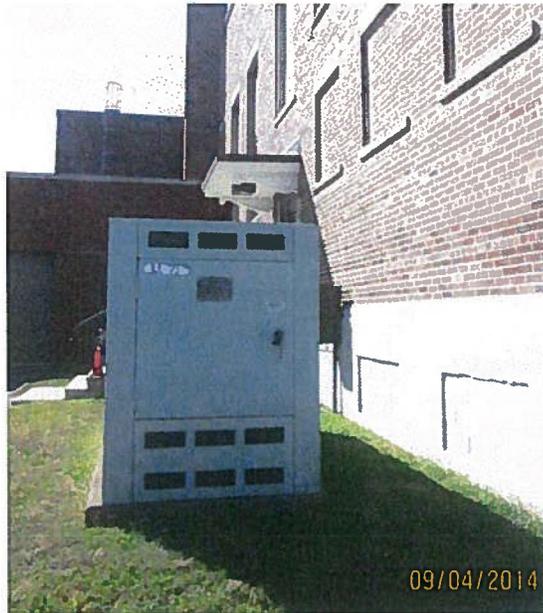
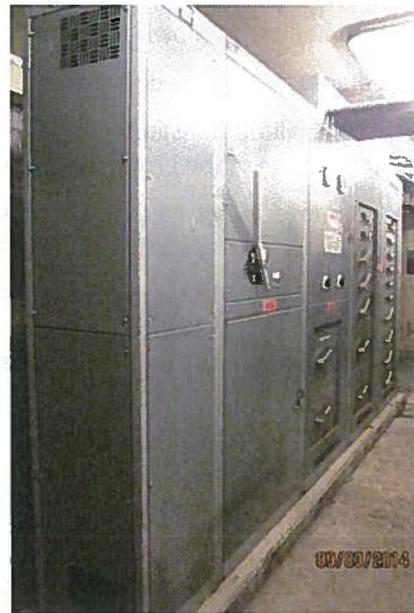
2. The switchgear is made up of 5 cabinet sections, "a wire-trough" "combination 1600amp main fused switch and metering section" and "3 sections of fused distribution". At the time of the site visit the facility's maintenance personnel stated that the electrical service was upgraded approximately 5 years ago, although the electrical switchgear appears to be in good operating condition the nameplate states it was manufactured in 1977.

3. The facility is estimated at 95,000 square feet which converts to the electrical service providing approximately 6.1 watts per square foot, if future plans for the facility includes providing a new centralized air conditioning system, then the existing electrical service will be undersized and will require an upgrade.

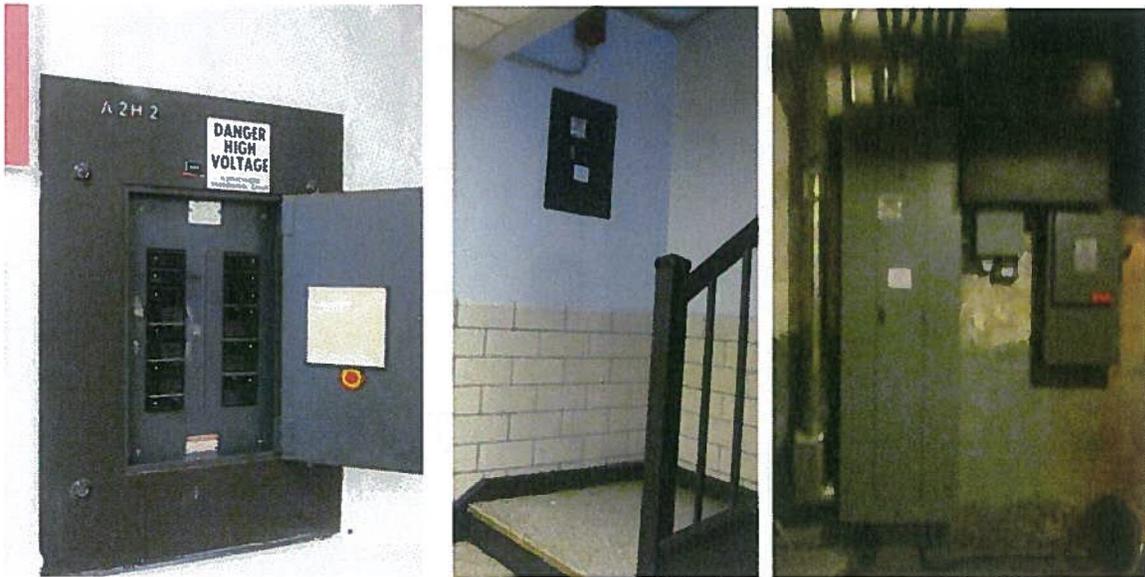
1. The existing distribution system consist of multiple surface and recessed local panelboards located throughout the facility's main corridors and closets. The existing panelboards are rated at 208Y/120Volts, 3-Phase, 4-Wire and support the lighting and receptacle outlets for classrooms and office within the corridor the panelboards are located.
2. The existing panel boards appeared to be in poor condition and since the installation of some of the panelboards do not meet the recent codes and are almost inaccessible, all of the panelboards should be replaced with new 208Y/120V 3-Phase 4-wire panel boards

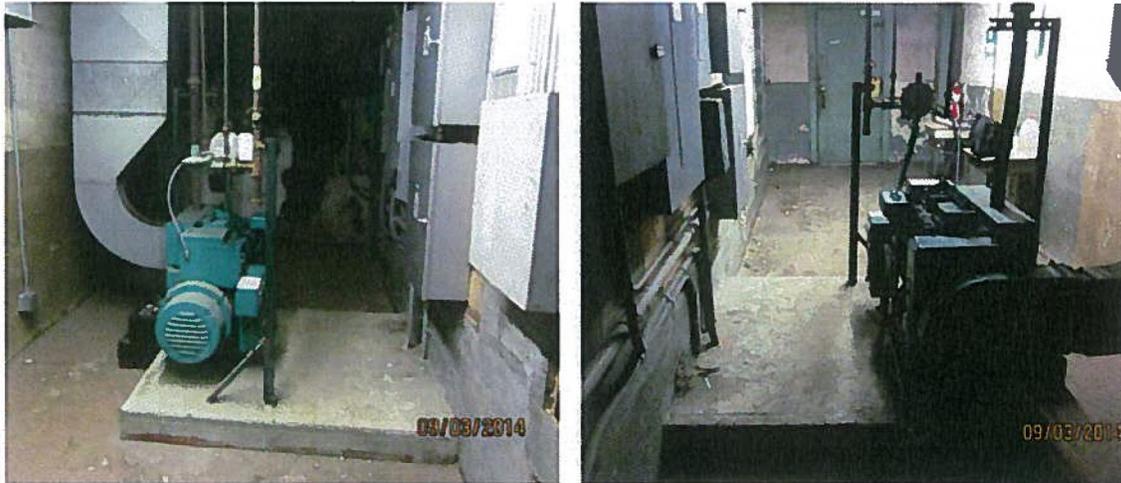
1. The facility is equipped with an emergency generator which feeds a 100amp panelboard, the emergency panelboards support the egress emergency lighting and exit signs. The generator and emergency panelboard is located within the basement of building "A" the generator system is rated at 15Kw/18Kva, 208Y/120Volt, 3-Phase, 4-Wire.

2. At the time of the site visit no information was made available pertaining to the date or installation of the existing generator. The installation of the generator and existing emergency panelboard do not meet the proper working clearance and produces a risk to personnel servicing the generator and/or panelboard located on the wall adjacent to the generator. The NEC2011 code requires a minimum working clearance of 36" between equipment, the existing installation has 24" clearance between the existing generator and panelboard.

3. Since the installation of the existing generator and panelboard do not meet code plus the generator appears to be undersized for the new emergency system, it is recommended that the existing generator system be replaced with a new larger generator to support the entire facility's emergency lighting requirements. An alternate emergency system can be installed if a new generator system is cost prohibited, new light fixtures with integral emergency batteries can be installed in lieu of a new generator system.

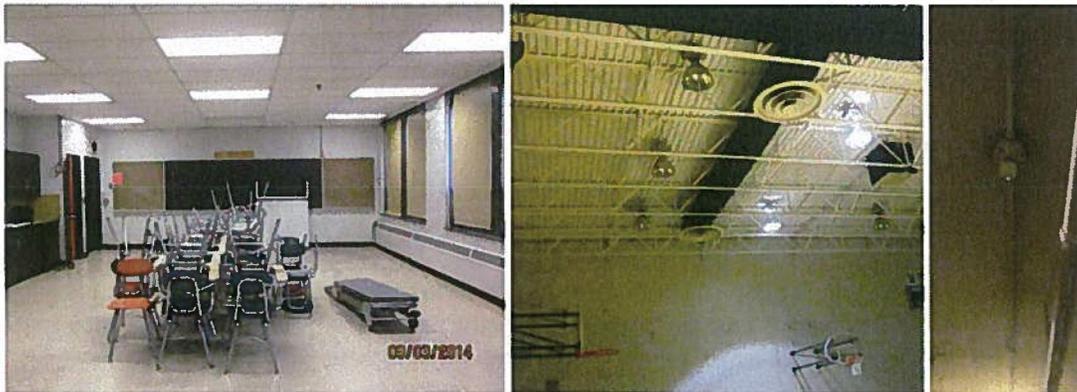
1. The lighting within the basement consists of a mixture of incandescent and utility fluorescent strips. The 1<sup>st</sup> and 2<sup>nd</sup> floor's light fixtures consist of recessed and surface mounted fluorescent light fixtures, the light fixtures within the classrooms and corridor appeared to be older T12 type fluorescent light fixtures which have been retrofitted with T8 lamps and electronic ballast, the gym area is equipped with round pendant mount high-bay HID light fixtures. Depending on the projected use of the facility significant lighting upgrades will be required. The retrofit of the existing T12 fixtures is beneficial however, all of the light fixtures are well past their expected life span and it is recommended that new energy efficient light fixtures be installed.

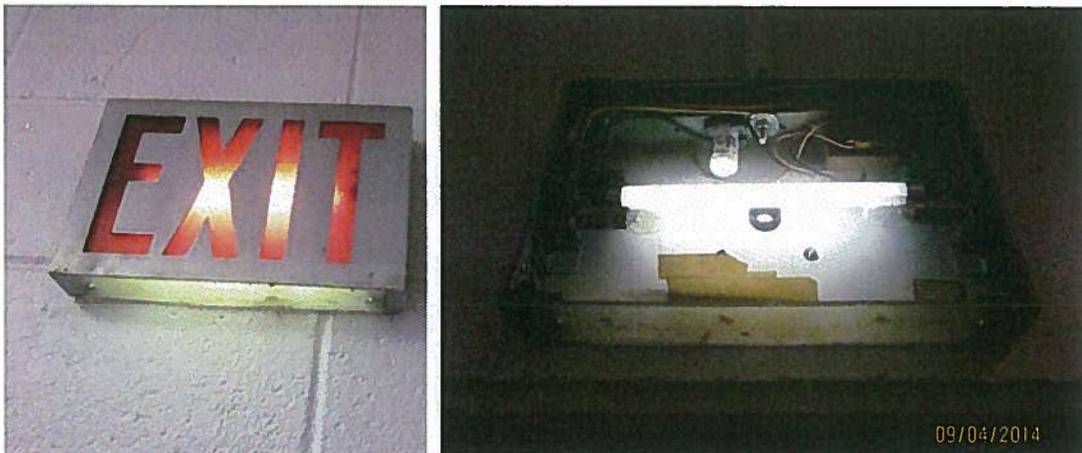
3. The exit signs are incandescent type with a separate integral emergency luminaire connected to the generator circuit. At the time of the site visit there were numerous exit sign which were not operational and had blown bulbs, other exit signs were flashing and had faceplate covers missing. All of the existing exit signs do not meet current energy codes and are past their expected life span and will need to be replaced with new LED type with integral emergency battery pack.

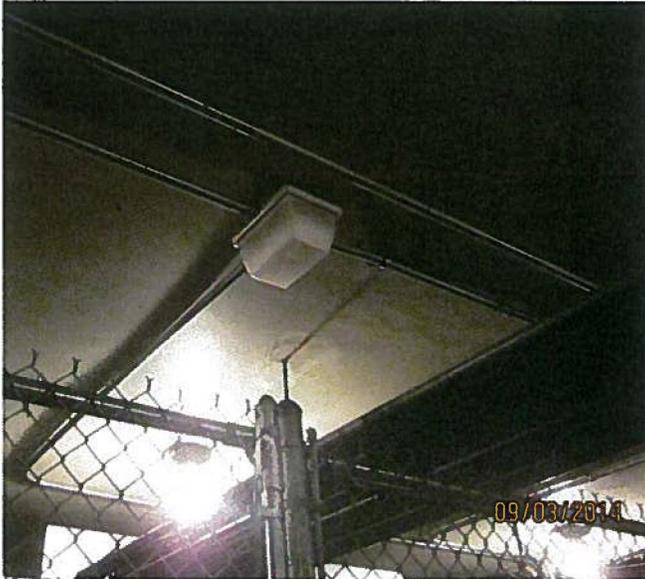
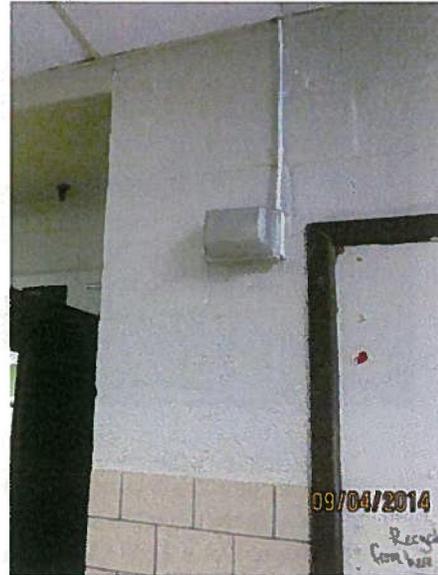
4. The emergency lighting consist of dedicated wall and ceiling mounted light fixtures, the light fixtures are not illuminated until the loss of power, once the generator senses the loss of power the emergency light fixtures will illuminate. There are no test switches for any of the emergency lights which requires a manual test of the generator and transfer switch to verify operation of the fixtures designated as emergency. The emergency light fixtures are installed within the ceiling and corridor walls between 35'-0" to 50'-0" on center, all of the existing emergency light fixtures appeared to be installed beyond the allowed coverage and some are passed their expected life span. In order to meet current life safety codes the existing emergency lighting system in its entirety must be replaced with a new emergency lighting system, either via integral

emergency batteries within new light fixtures or new light fixtures connected to a new emergency generator distribution system.

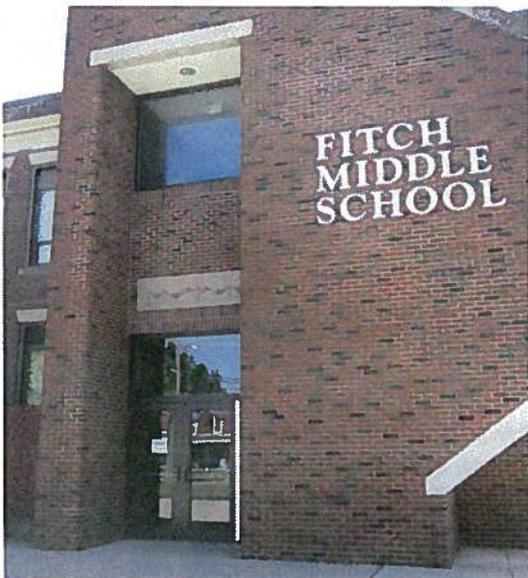
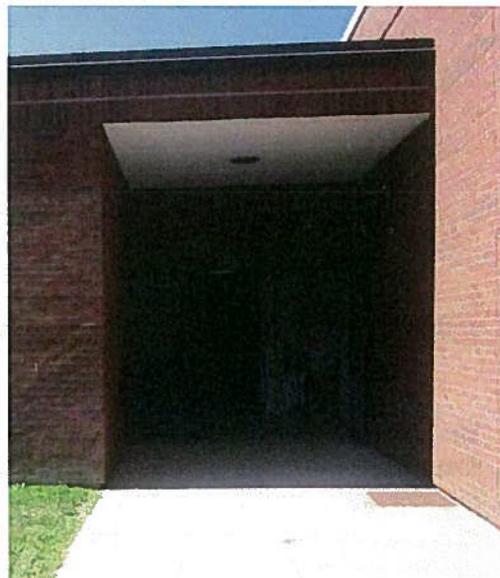
5. The egress door to the exterior did not have a code required 2 lamp emergency light fixture on the exterior above the door illuminating the exterior of the egress path, new energy efficient emergency light fixtures with integral photocell should be installed and interconnected with new time clock.

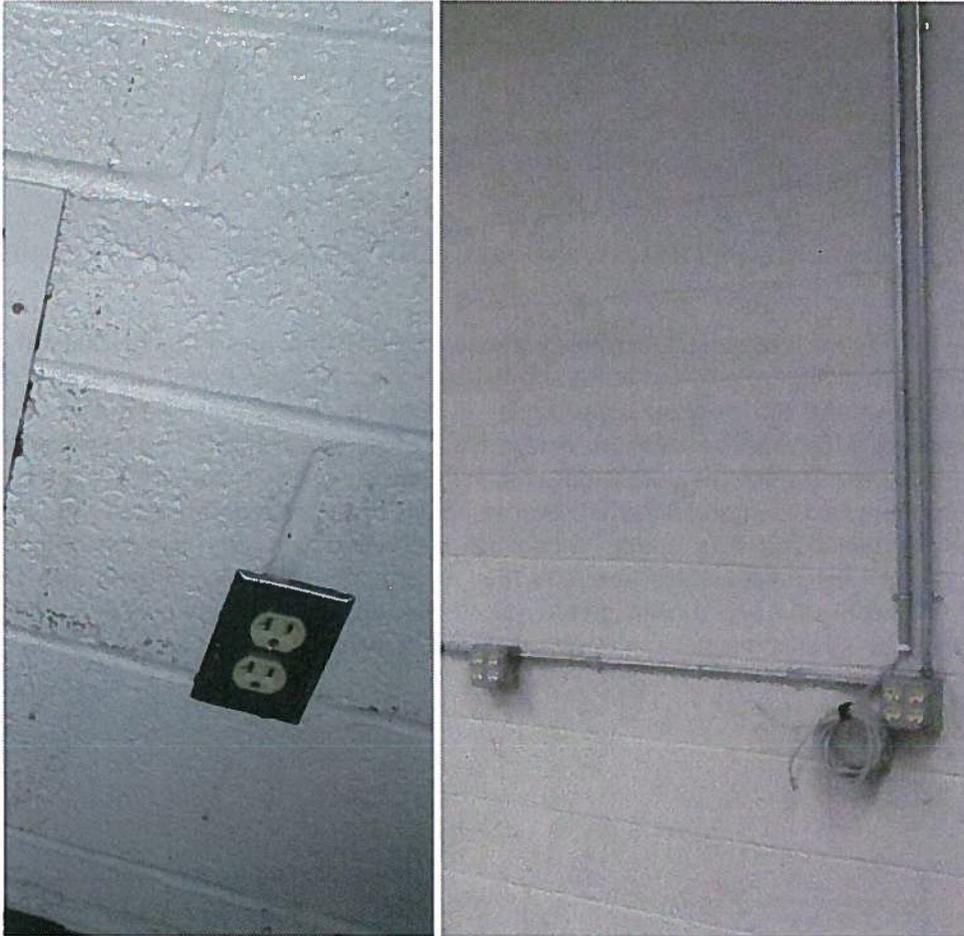
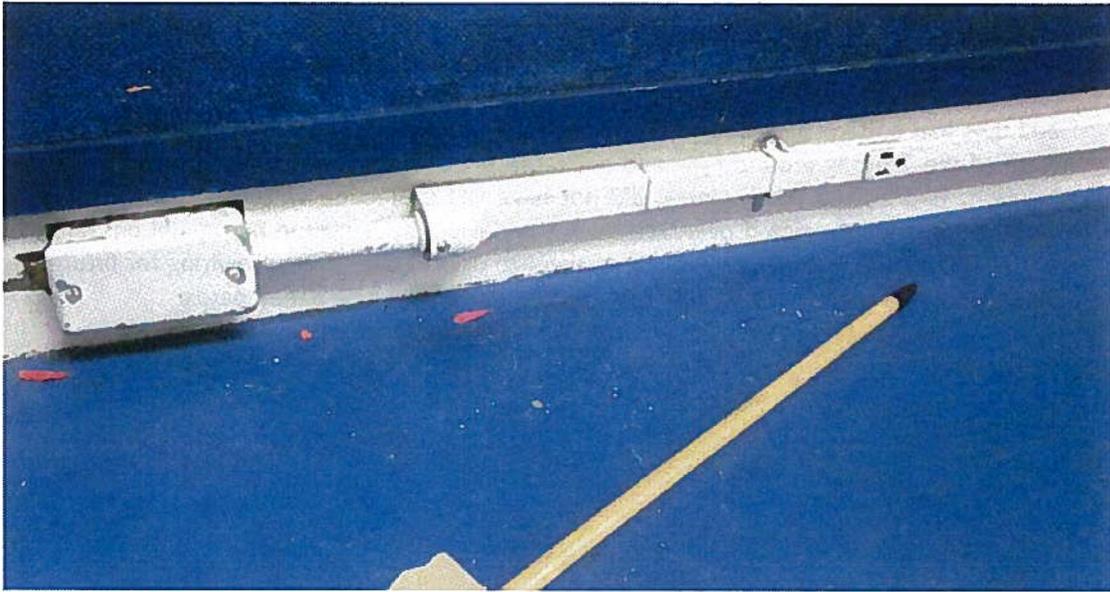
1. The existing receptacles within the facility consist of multiple manufacturer and most were recessed within the wall with some additional receptacles surface mounted, some classrooms and labs had surface mounted raceway and power poles throughout. Most of the receptacles were of the 3 prong ground type and appeared in good working order, however some outlet locations had broken cover plates, did not have GFI protection where required by code and some devices were painted over. Although the devices appeared in fair condition; due to the age of the devices and the probability of damage or breakage during rewiring for future needs we recommend any retrofit include new devices wired from new panelboards.

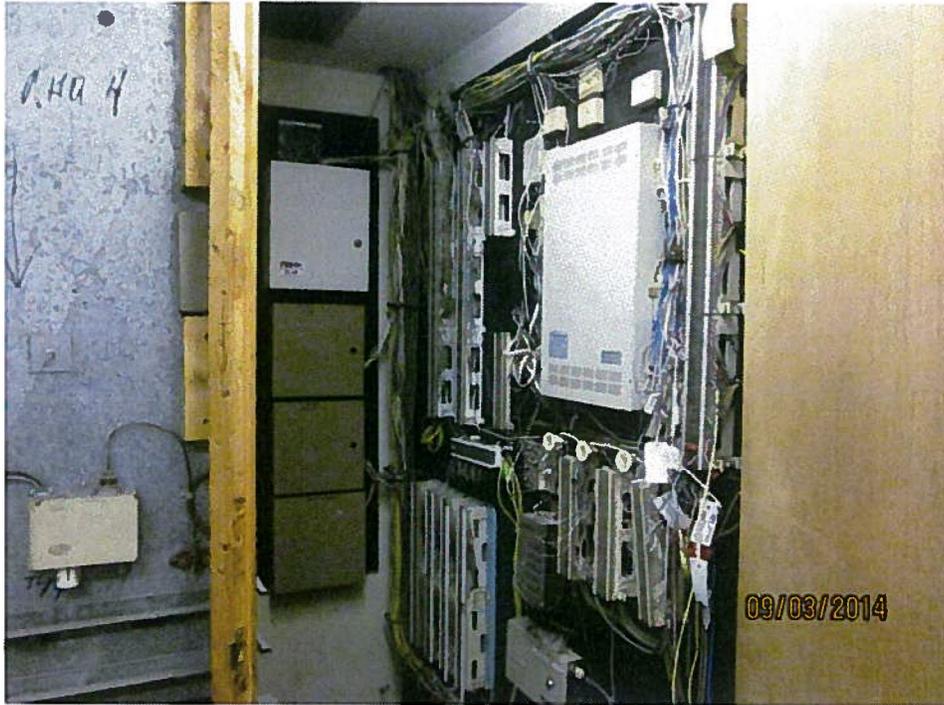
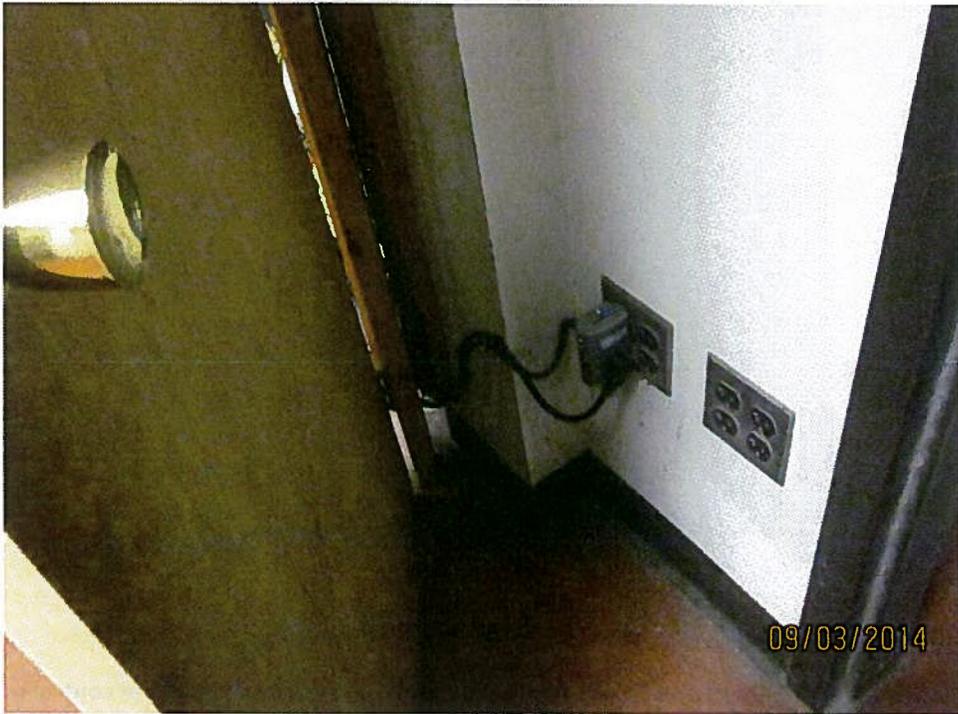
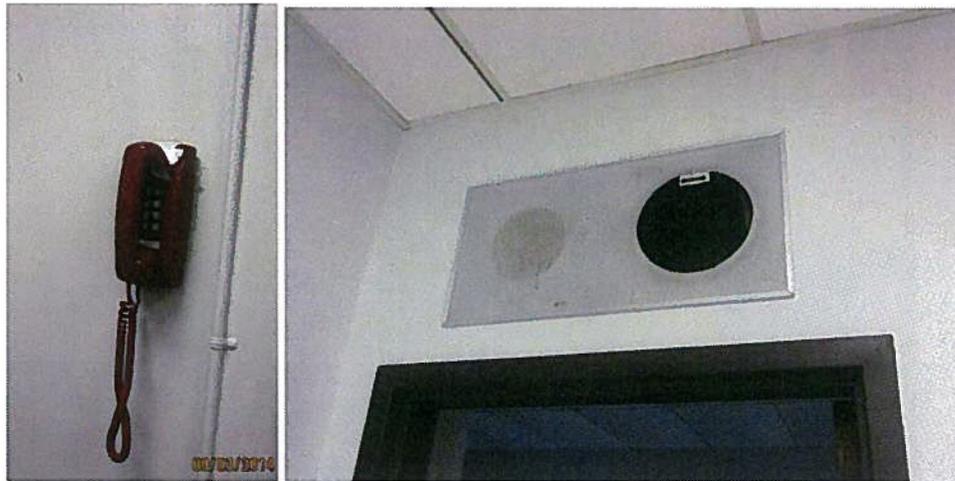
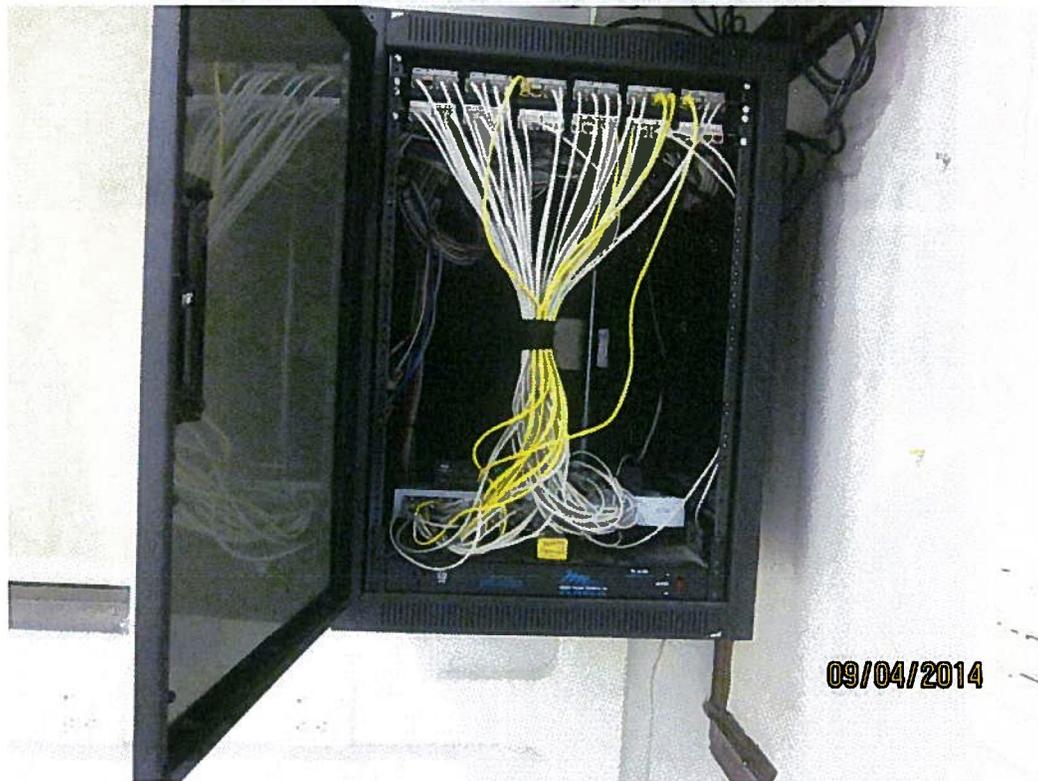
2. The existing Main telecommunication system is located within one of the mechanical rooms on level 1 of building "A" adjacent to the administration area. It appears that a makeshift closet was created around the telephone equipment utilizing the HVAC equipment and a door. The receptacle outlets for the telephone equipment are located outside of the said closet and power cords are run through the door jambs. The Tel/Com and speaker/clock system appeared to be mostly removed with occasional left over remnants of the system throughout the classrooms. The telephone and data outlets within the classrooms was very minimal and data racks appeared abandoned within some of the classrooms. It is recommend that the entire telecommunication system should be removed and replaced with new upgraded infrastructure within a designated telephone room to meet today's telecommunication needs.

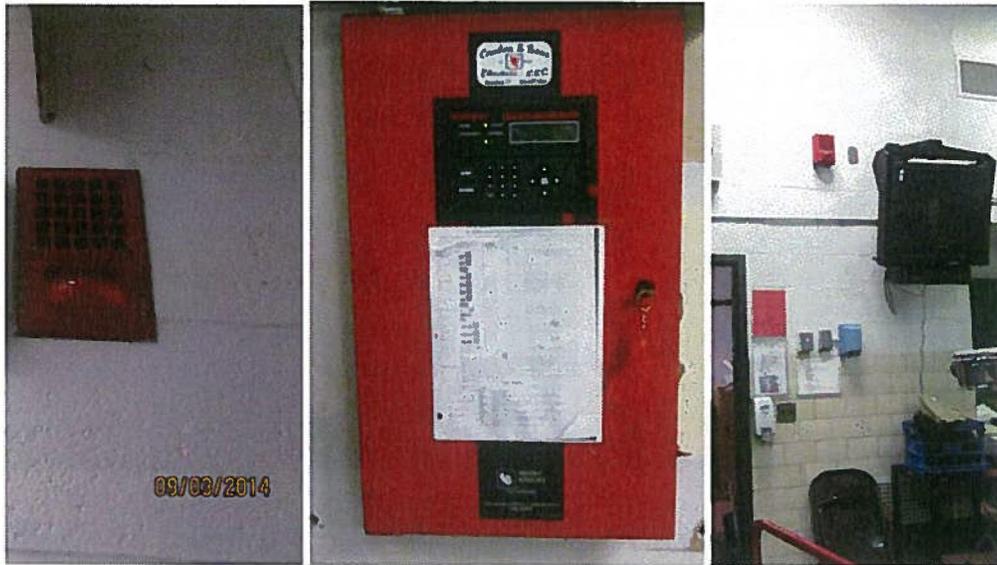
1. The existing fire alarm system consist of a 20 zone Silent Knight fire alarm control panel "FACP" located within the main office area of level 1. At the time of the site visit the fire alarm system was in the trouble mode and was continuously beeping.
2. The fire alarm devices consist of a mixture of manufacturers and the installation of most of the horn/strobe do not meet proper required coverage, also none of the strobe meet the ADA

requirements. None of the single stall toilet rooms were equipped with fire alarm strobes nor had a call for aid pull cord.

3. The majority of the classrooms did not have fire alarm notification devices and smoke detector coverage was at a minimal. Due to the quantity and types of additional devices required to address code compliance it is recommended that the entire fire alarm system including FACP, notification devices and annunciation devices be replaced with a new digital addressable fire alarm system.

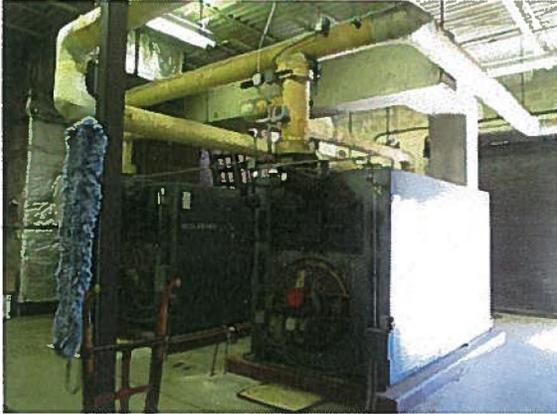
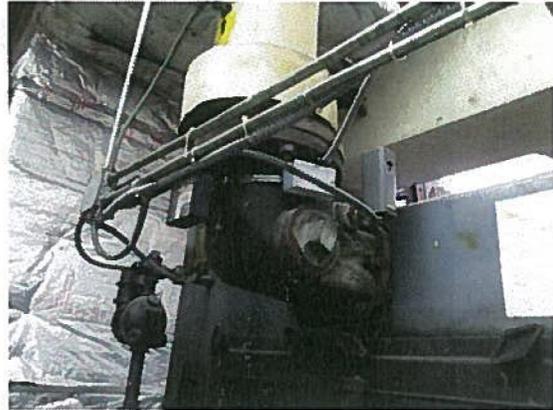
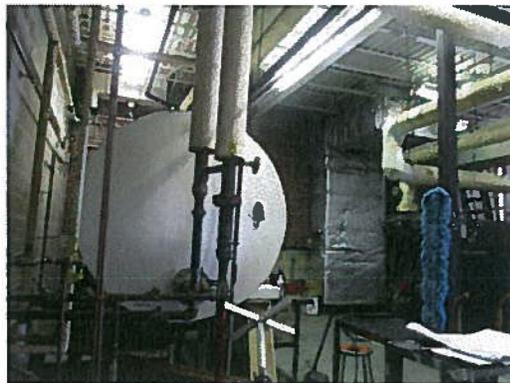
5. The existing building's heating system is served by oil fired (2) boilers, "Weil McLain," Model AH-1994-W-F, 4,060 MBH of heating capacity, located in the Basement (Part A). The two boilers are piped such that domestic water heater could provide hot water to the building. The heating boilers currently modulate as required to maintain a constant discharge water temperature. The heating boilers are working and in fair condition, but approaching the end of their useful life.

1. Remove the (2) existing boilers, accessories and provide new (2) high efficiency hot water boilers. Size of new boilers to be determined based on the renovation work, building heating load and ventilation air requirements for new systems.
2. The existing fin tube radiation should be reused to provide heat to new spaces. The piping connections should be reused and modified, if required.
3. The main portion of existing heating water piping can be reused.
4. The capacity of existing heating pumps should be evaluated and replaced, if required.
