BUILDING CONDITIONS ASSESSMENT  
*for*  
Fitch Middle School  
Town of Groton, Connecticut

*Architect:*

TLB Architecture, LLC  
92 West Main Street, Chester, Connecticut 06412

February 27, 2015

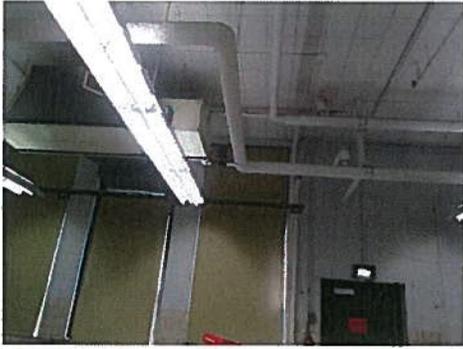
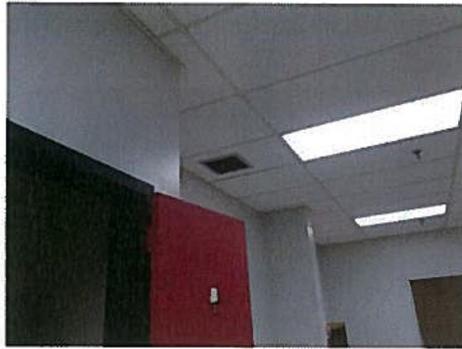
6. The heating circulation piping system is composed of steel and copper piping. The piping system served fin tube radiation in Classrooms, Offices, Exam room, Shops (Part A, Part B, Part C, Part D) as well as unit ventilators located in wood shop, metal shop, AHUs, serving Auditorium, Front Offices, Library, Music room, Gymnasium, Cafeteria and CUH, located on second floor (Part B).

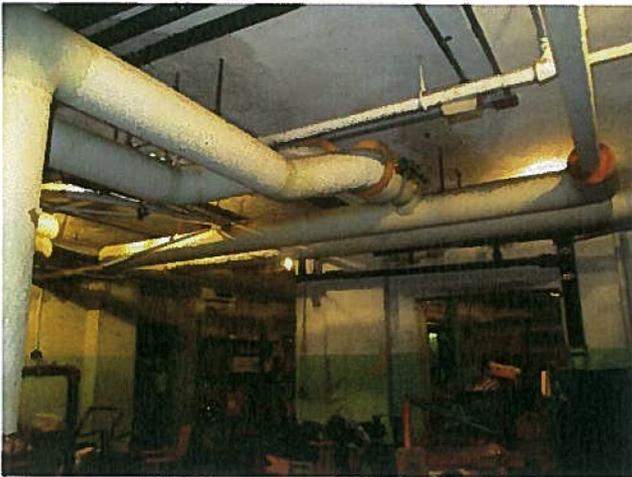
7. The distribution piping system appears to be in good condition however when the building is renovated significant modifications to the piping will be required.

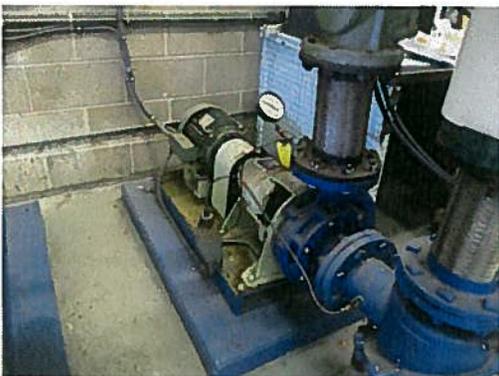
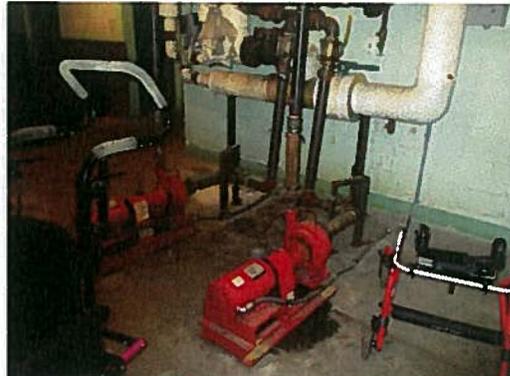
The heating water is circulated throughout the building by two (2) primary and two (2) secondary base-mounted pumps. The pumps are in good condition, however, when the building is renovated, replacement of the pumps will be required.

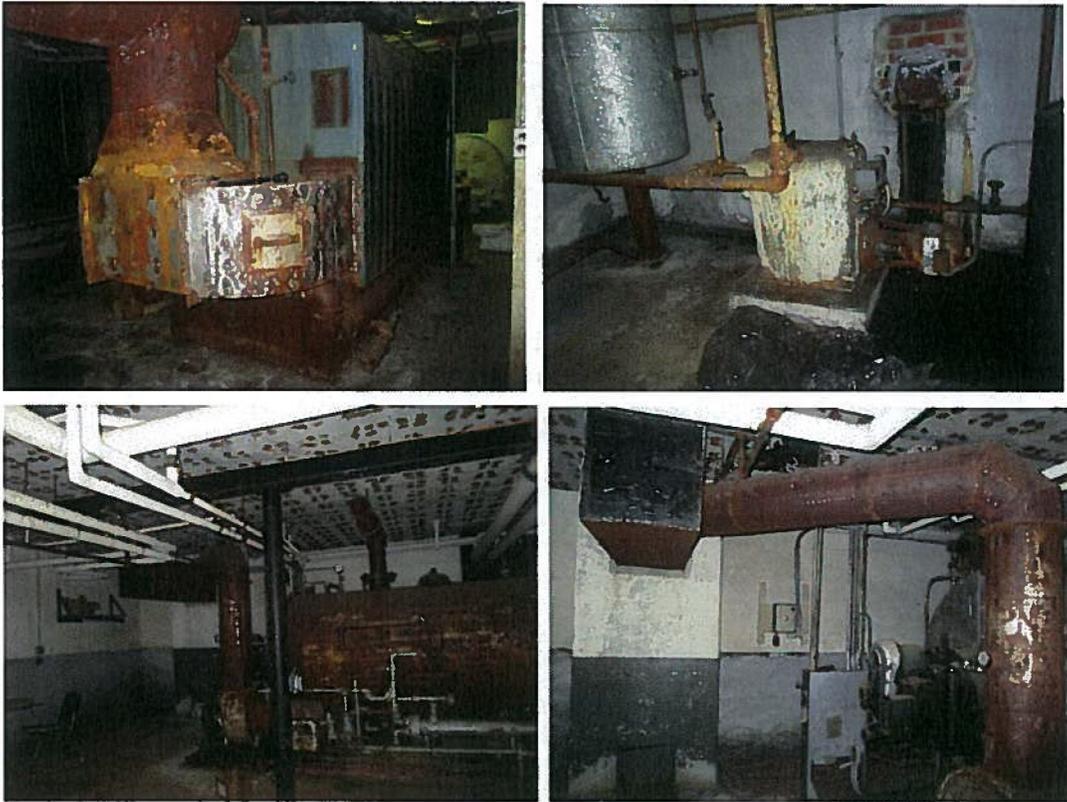
The abandoned boilers and condensate pump located in basement (Part A and Part D) should be removed.

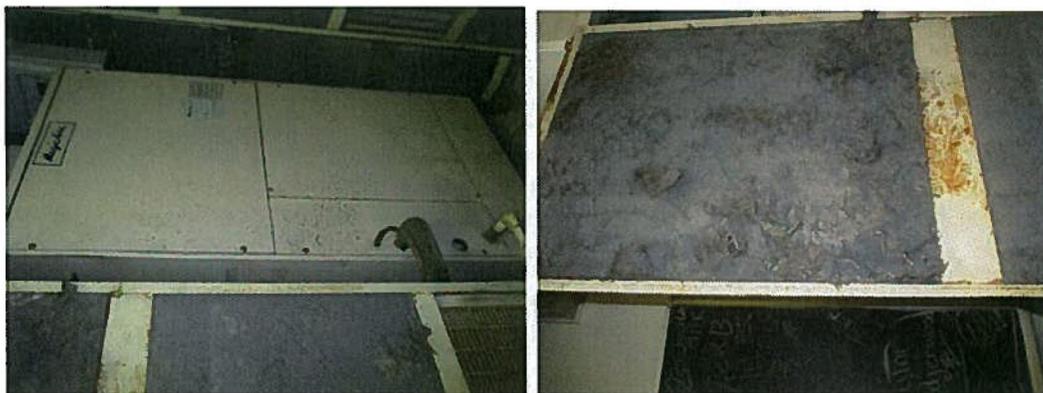
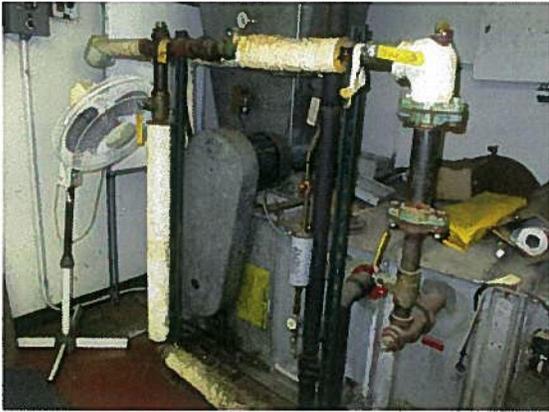
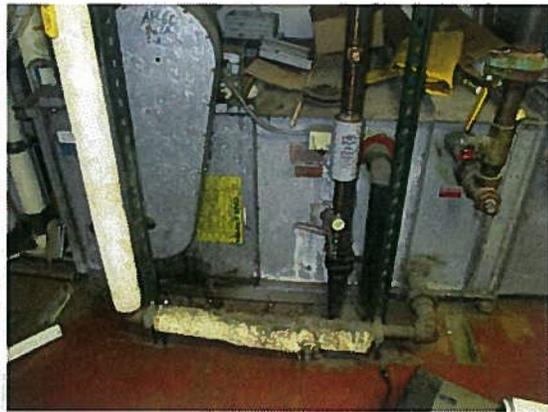
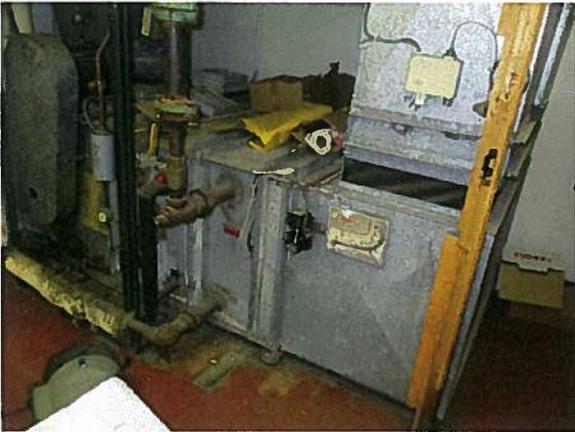
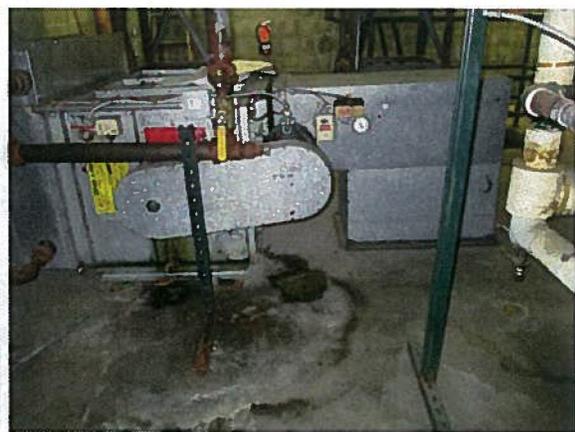
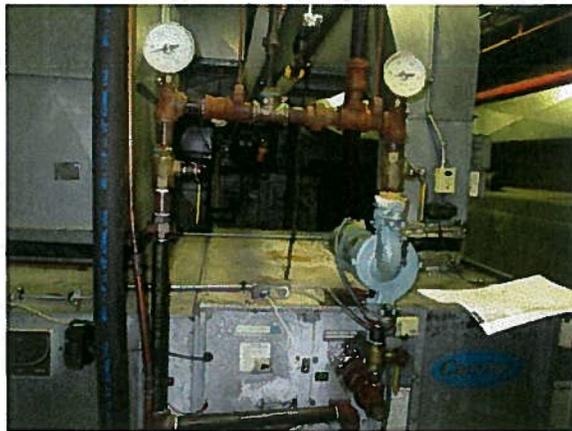
1. The AHUs serving the Front Offices, Auditorium, Library, Music room, Gymnasium and Cafeteria are not in good condition and are approaching the end of their useful life.

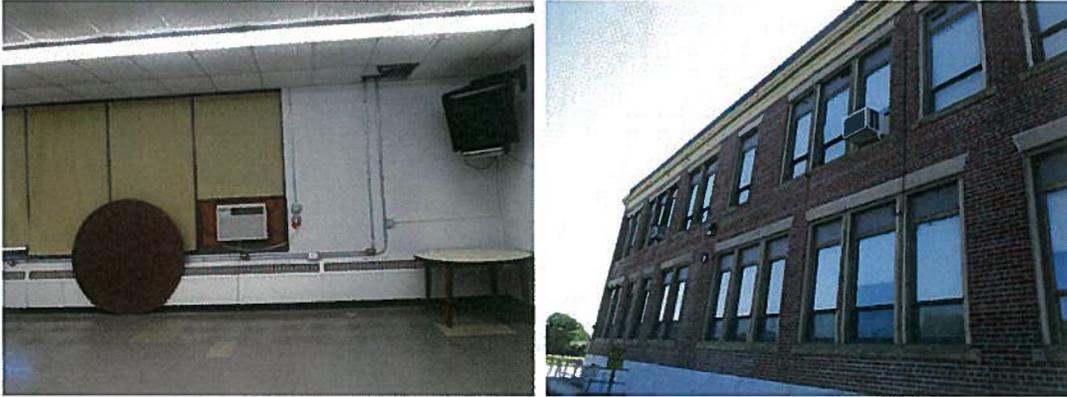
2. Window AC units are serving some offices and classrooms throughout the building.

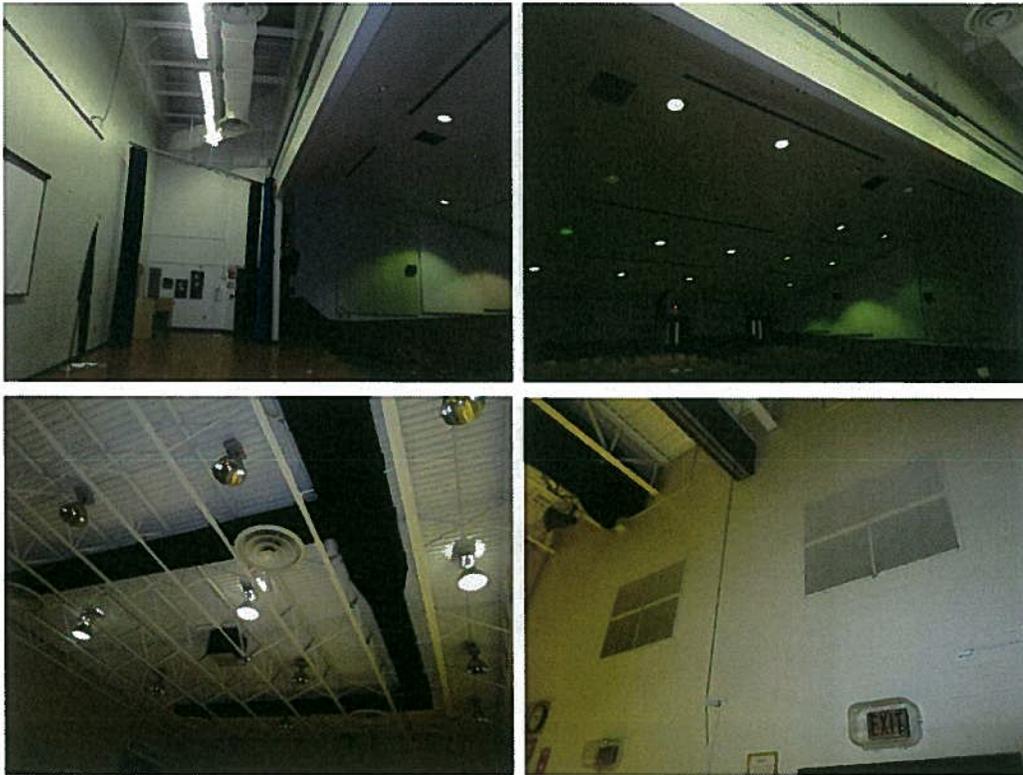
3. The existing air distribution systems to the auditorium and gymnasium are in good condition.

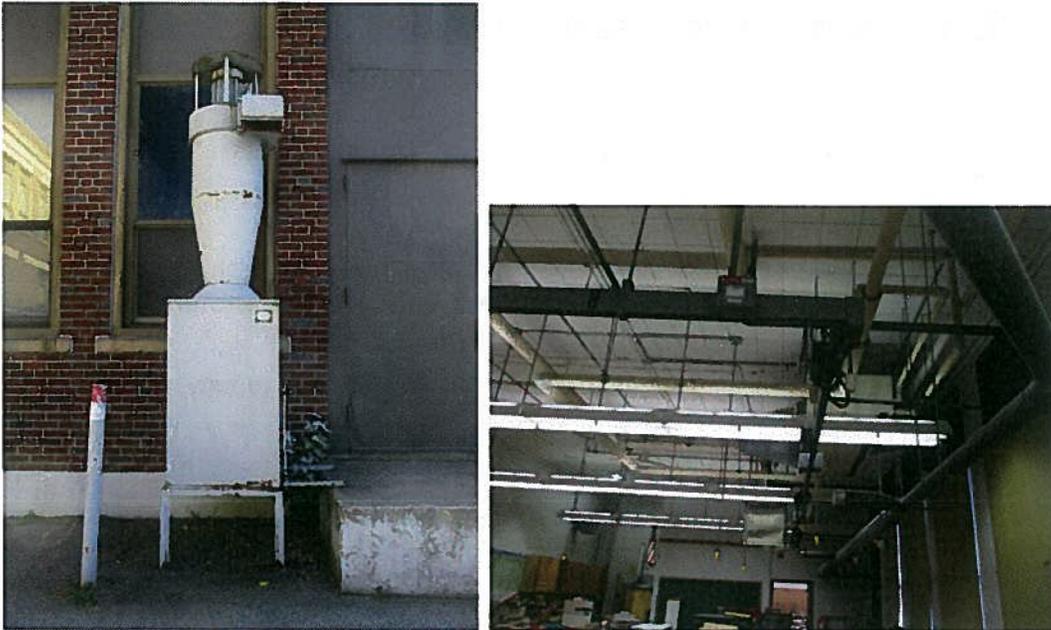
5. The existing dust collector and exhaust ducts, located in the wood shop, are in bad condition and approaching the end of their useful life.

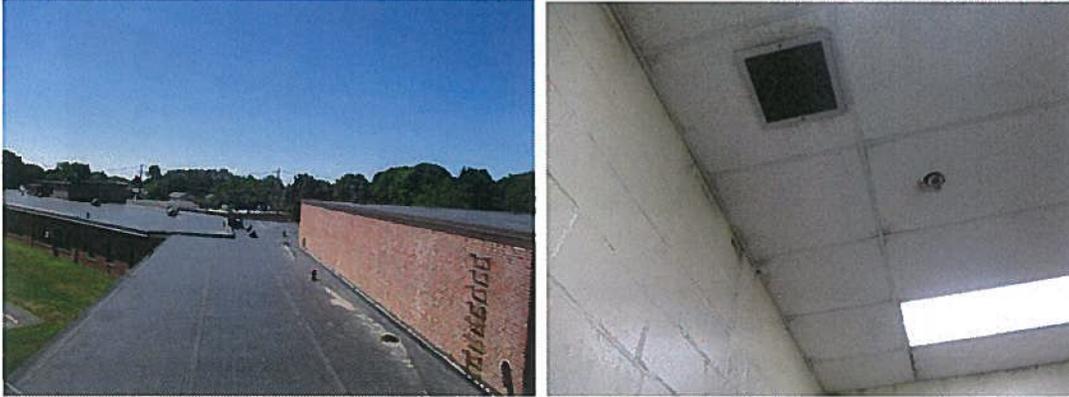
1. The exhaust distribution ductwork from spaces and corridors and exhaust fans, located on roof throughout the building, are in fair condition and approaching the end of their useful life and will need replacement.
